SUBJ: Main Landing Gear

Introduction

This Special Airworthiness Information Bulletin (SAIB) informs registered owners/operators of Taylorcraft airplanes (including all **Taylorcraft, Inc., Taylorcraft 2000, LLC, and Arizona Aerospace Foundation** model aircraft under type certificate data sheets **1A9, 1A11, TG-6, A-643, A-696, A-699, A-700, A-746, and TG-6**) with main landing gear (MLG) tie strut part number (PN) B-A51 of an airworthiness concern. Specifically, this SAIB provides guidance on mitigating action to prevent your MLG tie strut from failing due to corrosion.

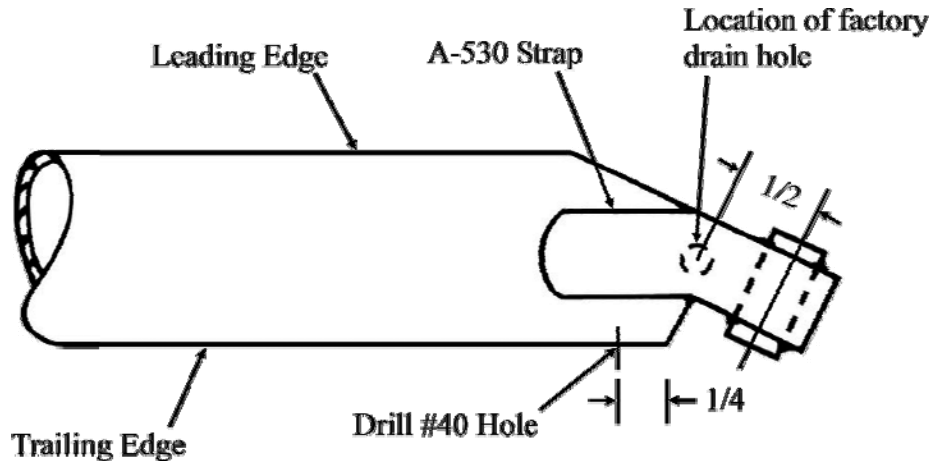
In March 2010, a Taylorcraft BC12-D airplane experienced failure of the MLG tie strut during landing causing significant damage to the airframe structure. The tie strut streamline tube failed 5 inches above the lower attach lug due to severe corrosion, resulting in reduced strut wall thickness. The lower section of the tie strut was full of corrosion and sediment, and the drain hole was plugged with debris and moisture.

Figure 1: MLG Tie Strut Lower End with Factory Drain Hole in A-530 Strap Lower Surface or in Strut Trailing Edge

- 1) Remove any fairings as necessary to gain access to the lower portion of the gear leg for inspection.
- 2) Locate the factory-installed drain hole located either on in the PN A-530 strap that attaches the lower lug to the strut tube, or at the trailing edge of the tie strut (See Figure 1). In the absence of a factory-installed drain hole at either location, locate and drill a #40 drain hole in

- 3) Inspect the area around the drain hole and note any water draining from, or rust particles exiting, the hole. Insert a wire or #40 drill bit into the drain hole and inspect it for the presence of rust particles.
- 4) If any rust particles or debris are noted while performing step 3, do the Additional Inspection Procedure below as necessary.
