service bulletin

M76-8
FAA-DER Approved

13 April 1976

SUBJECT: INTAKE VALVE CHANGE

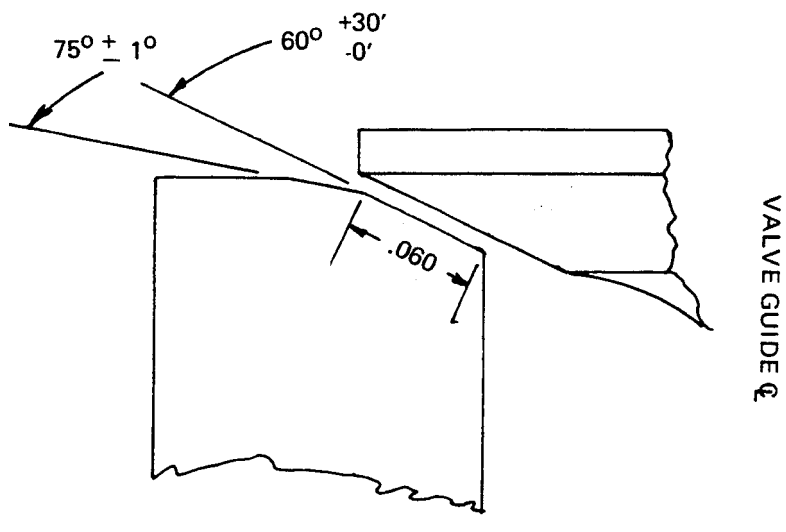
FIGURE 1.

It should be pointed out here that this valve design is commonly referred to as a "30° angle valve"; however, the standard design practice is to dimension the valve face angle off of the valve stem centerline and the valve seat insert off of the valve guide centerline; thus, the 60° shown in the sketch.

It is permissible to install the new valve on the old 45° seat insert after first grinding it to the correct angle as shown in Figure 1. However, installation of the new insert (P/N 641793) is highly desirable and both the new intake valves which supersede P/N 531608 and the new inserts which supersede P/N 3912, should be installed at the next top overhaul or major overhaul, whichever comes first.

If you install these new intake valves in cylinders which incorporated valve P/N 531608 (see cylinder part numbers listed under - "old") it is necessary to regrind the intake valve seat insert to 60°, +30' -0', to the valve guide axis to obtain a 0.060" (approx.) seat width. The seat O.D. must be kept within the O.D. of the valve face as per Figure 1. If reducing the O.D. is required, it can be accomplished with a second grind of 75°, +/- 1° as indicated.
