Airworthiness Concern Sheet

Make, Model, Series, Serial No.: Taylorcraft, all models equipped with landing gear.

Reason for Airworthiness Concern: Failure of the Main Landing Tie Strut, Part Number B-A51

SERVICE BULLETIN

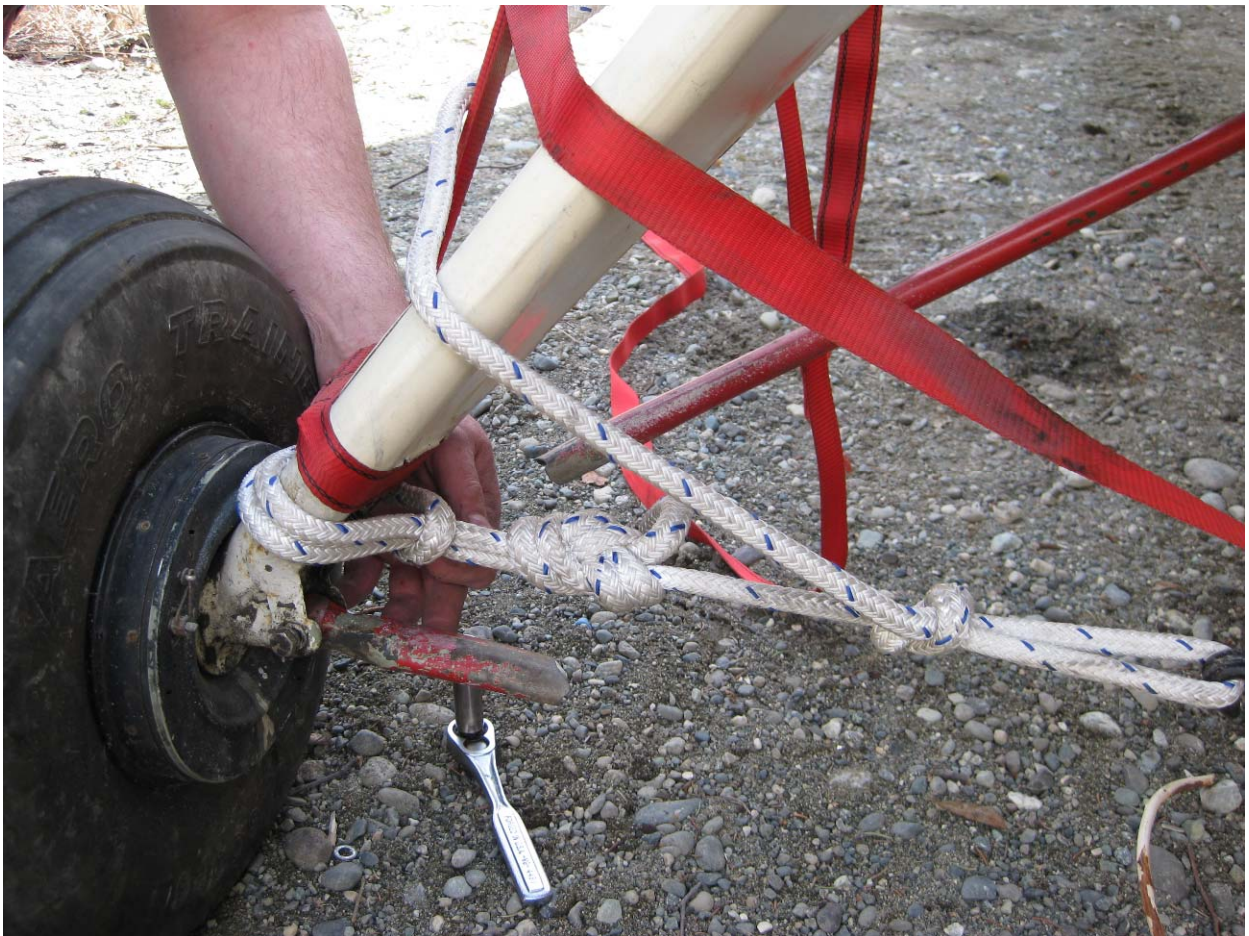
FAA Description of Airworthiness Concern: A Taylorcraft BC-12D right main landing gear failed on landing when the landing gear tie strut broke approximately 6 inches inboard from the wheel. Investigation found the tie strut to be internally corroded and the probable contributing factor to the failure. Pictures of the failed tie strut are attached. Taylorcraft Aviation Corporation Service Bulletin No. 78-001 (attached) requires owners to check the strut drain hole for blockage, and to drill a drain hole if one does not exist.

Failed Tie Strut on RH Main Gear

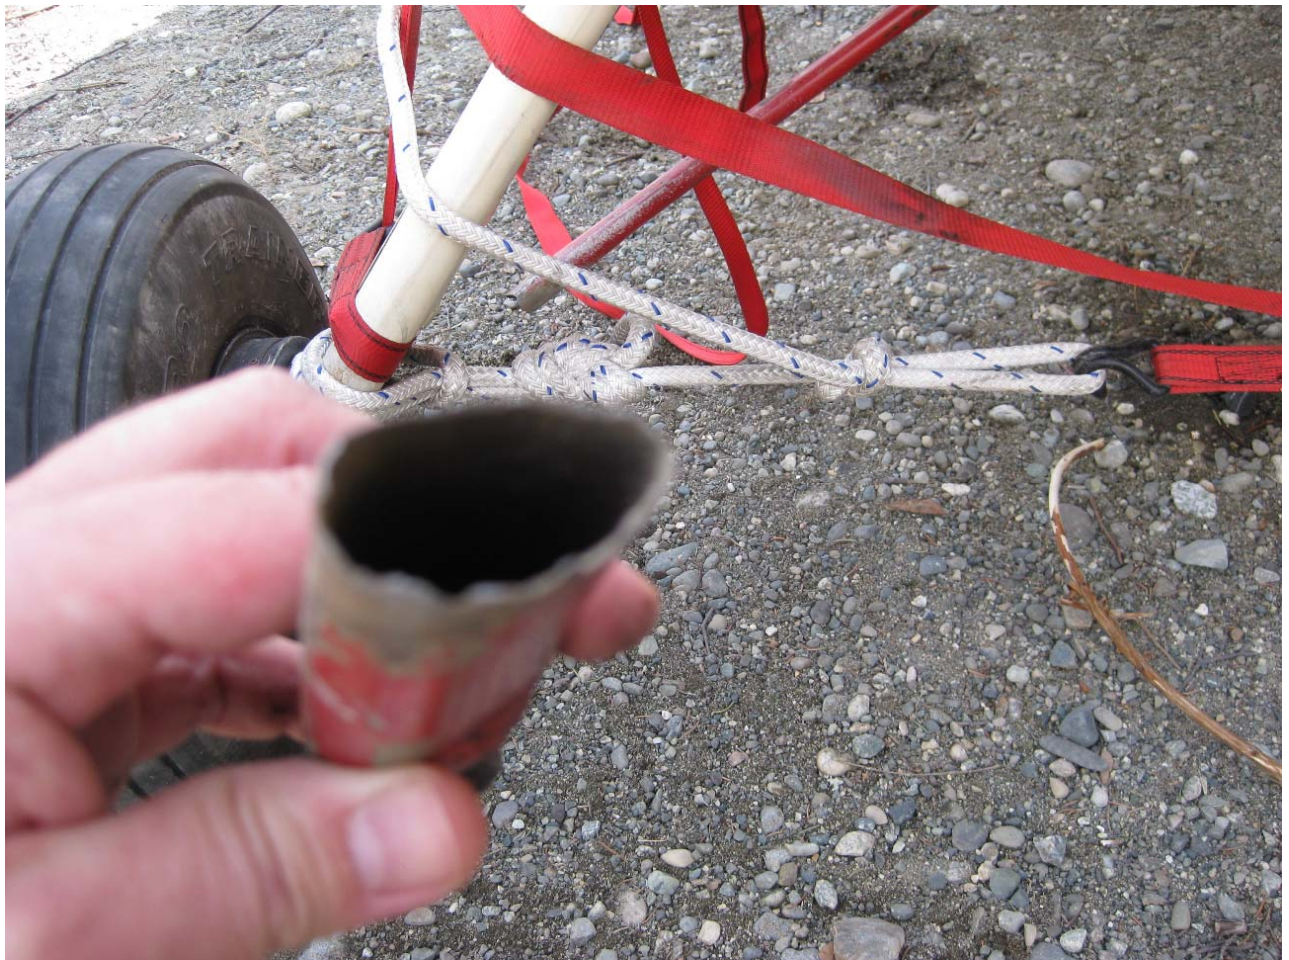
Broken End of Tie Strut (Removed from Aircraft)

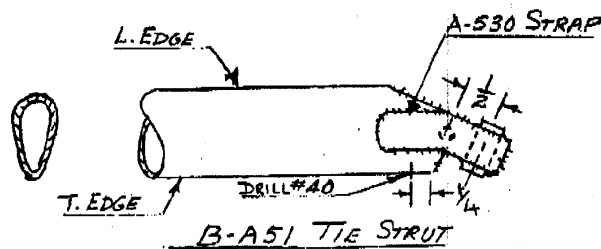
FIG. 1.

Note that drain hole is either located at center of strap (TAC P/N A-530) and/or at trailing edge of tie strut. Only one hole is sufficient for drainage.

COMPLIANCE PROCEDURE: (1) Inspect landing gear tie strut (TAC P/N B-A51) near "bolt" at axle for obstruction or foreign material in drain hole

(2) If drain hole(s) is (are) plugged, open with suitable means.

(3) If none of the drain holes exist, drill #40 in trailing edge as shown in Fig. 1.
