Taylorcraft Aviation Corporation

SERVICE BULLETINS

21 – March 27, 1940

34 – January 21, 1943

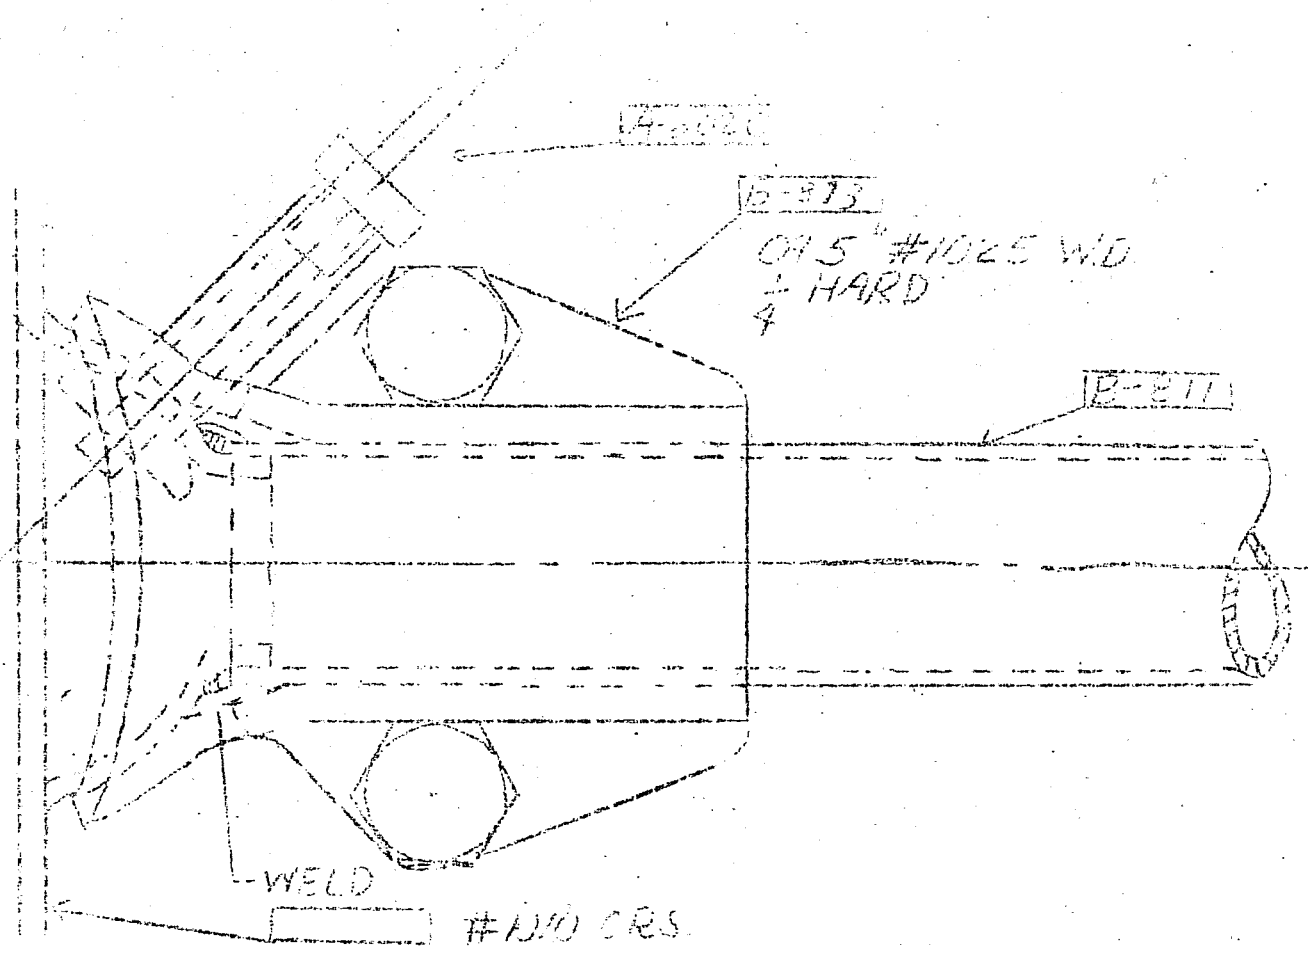
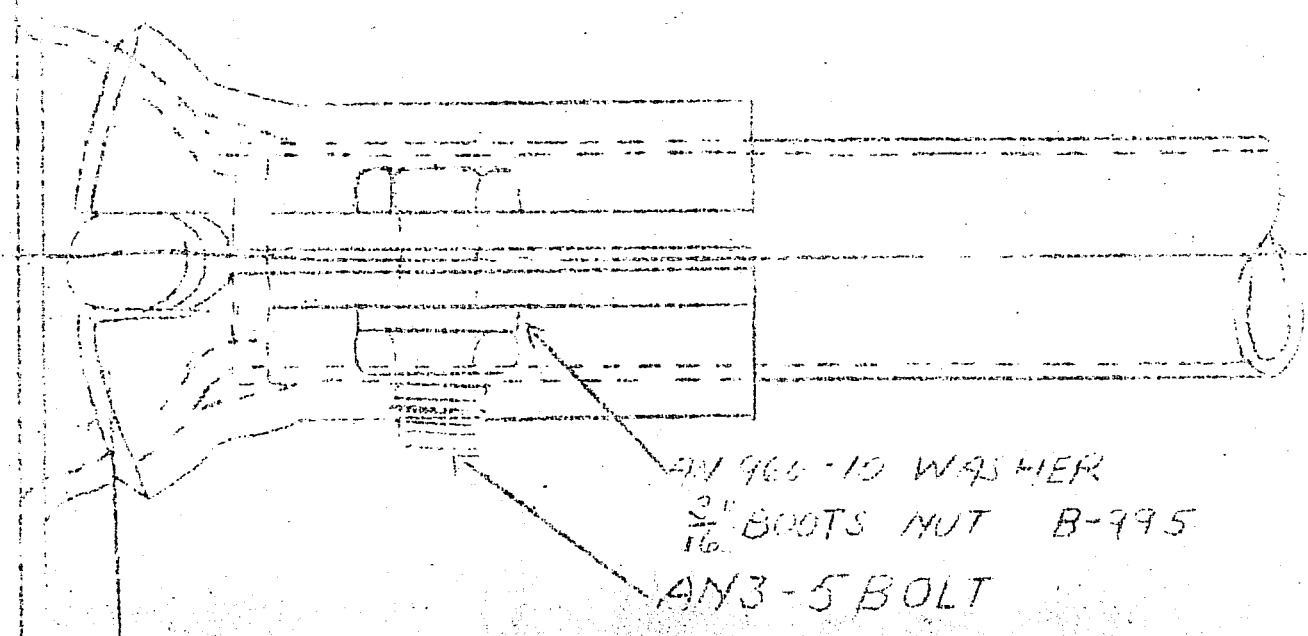
The enclosed print shows the drag strut reinforcing fitting installed in the wing. There is an inspection opening at each strut foot intersection except at the end of the outer bay.

SLOT IN REINFORCEMENT
 240" WIDE $\frac{1}{2}$ " LG

Enclosed with the shipment of parts are four extra rings for each wing, to be installed on the under surface of the wing, as shown on the accompanying print. When these have been installed, cut out the circular pieces of cloth inside the twelve rings as shown on the sketch but it is not necessary to cut the two rings nearest the lift strut fittings.

The reinforcing fitting is in two halves. Place the bolts in the upper half and install the upper half of the fitting on the tube and over the drag strut foot, so that it lies over each brace wire fitting. Put the lower half in place using two washers under each of the Boots self-locking nuts. The bolt will not turn, but the washers under the nut permits the nut to turn. The nut is self-locking and does not need a cotter pin. When installing, tighten the bolts snugly, then tap the reinforcing fitting out toward the spar, making sure that it is in contact with the drag strut foot underneath. It is also important to watch that the gap in each side of the fitting is uniform, because if one side is pulled up tighter than the other, it is apt to bind on one wire and leave the other one loose and cause the fitting to lose some of its efficiency. Then pull the bolts up real tight as it is important that this fitting does not slide along the tube.

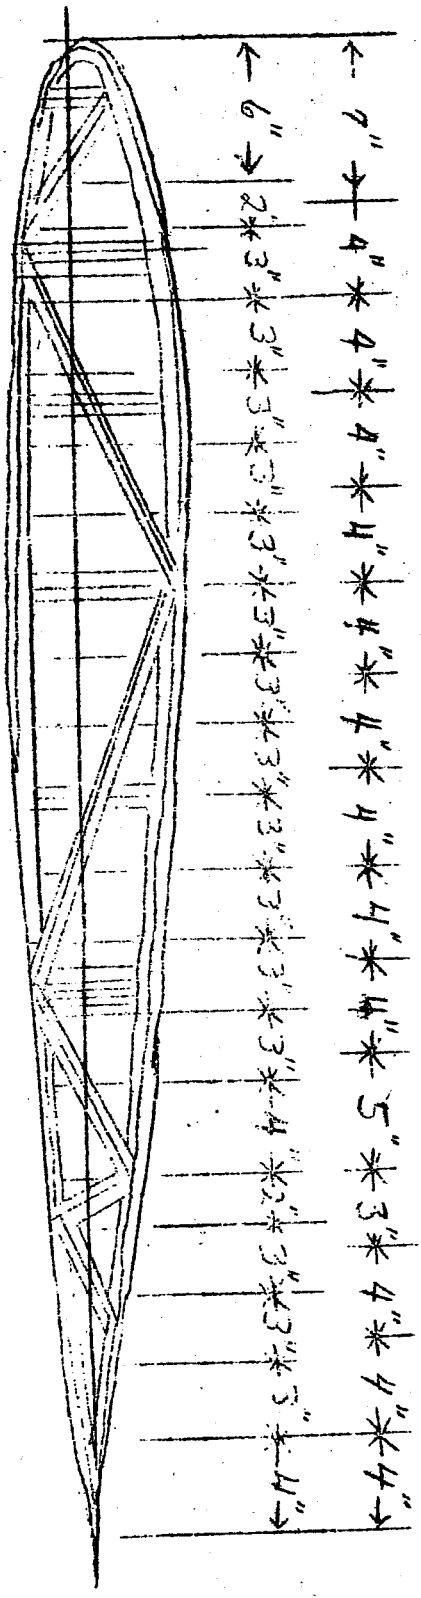
It has been brought to our attention that in a few instances the rib stitching in the wings have become chafed and broken, creating a hazard while engaged in high-speed maneuvering.

NOTE - 3" DIMENSIONS ARE FOR FIRST THREE RIBS FROM ROOT
 4" DIMENSIONS ARE FOR ALL RIBS FROM THREE ON OUT

Therefore, we believe it urgent that you immediately inspect the rib stitching on the wings of your airplane, and if any stitches are found broken that they be immediately re-stitched.

A 6-U linen rib stitching cord should be used. The first three ribs from the wing butt should be stitched every three inches starting from a point eight inches behind the leading edge of the wing, and the remainder of the ribs should be stitched at four inch intervals beginning at a point seven inches behind the leading edge.

It is not necessary to install the reinforcing tape under the stitches, but merely stitch through the standard finish of the wing and install a strip of pink tape over the rib and the stitching.

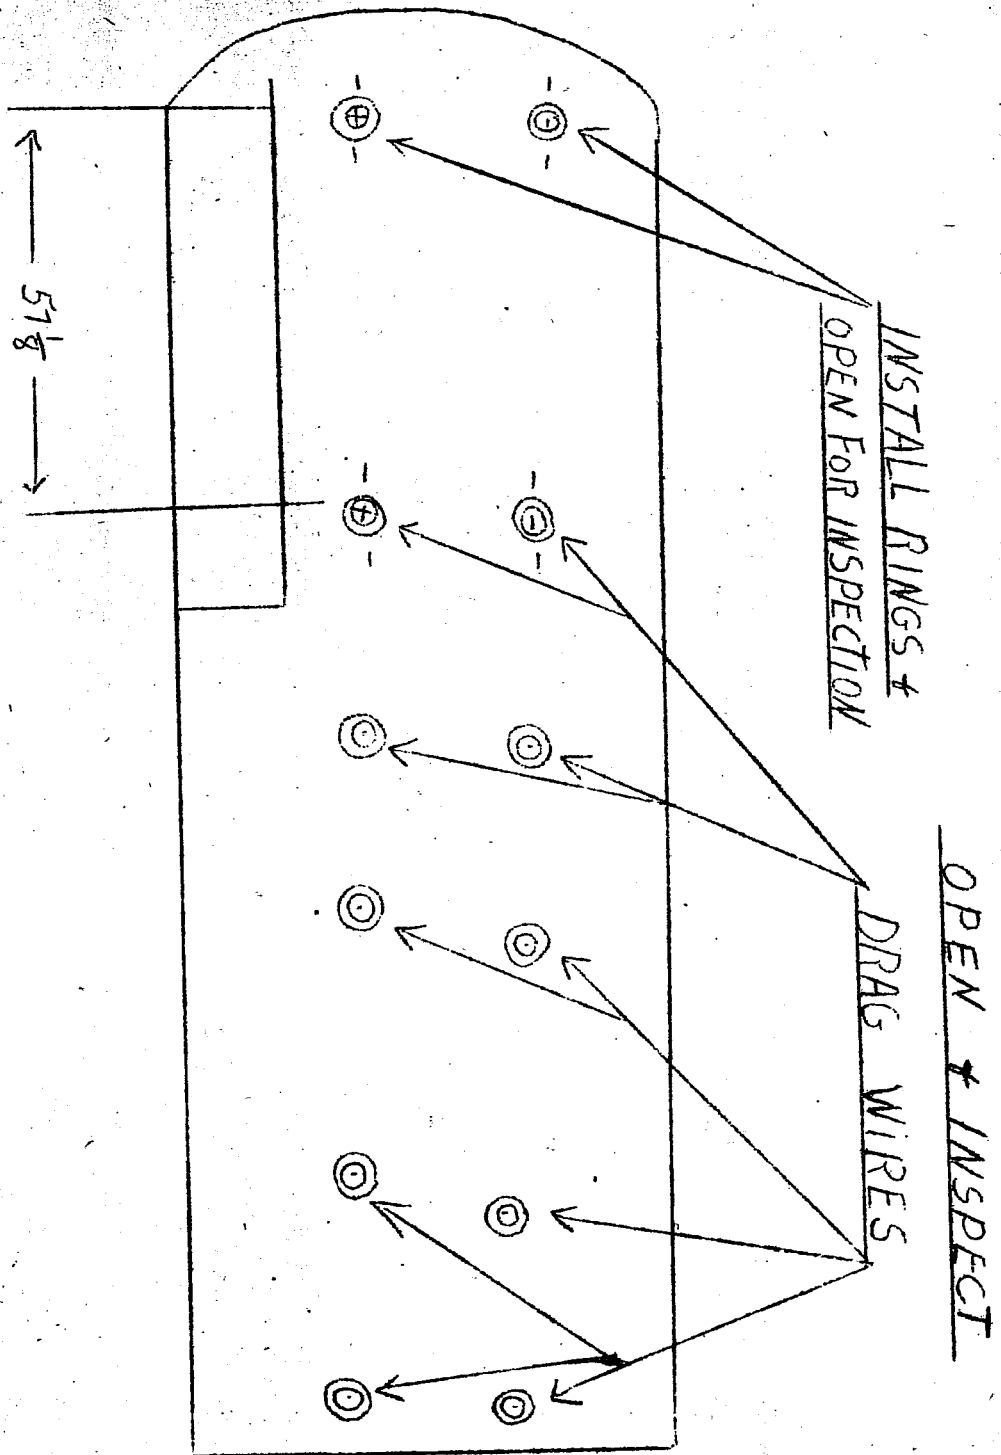
It has come to our attention that on the above group of ships the wing drag wires may not have been tightened enough. Therefore, we request that you have the wires checked in your ship and tightened if they are loose.

Cut the circles out of the grommets that are installed on the wings for this purpose as shown on the accompanying sketch. The wires should be rigged by turning the nipple until the wire is tight, but care should be taken not to rig too much initial tension. After the nipples are adjusted, be sure the lock nuts are tightened by holding the nipple and turning the nut.

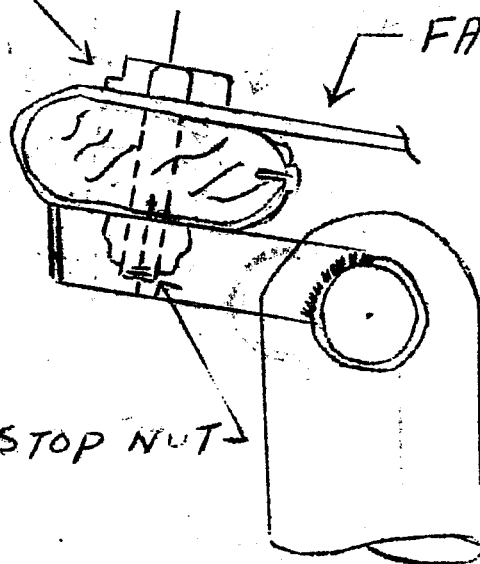
It has come to our attention that there is a possibility that some operators may be lowering the seat incorrectly to accommodate parachutes.

LOWERED POSITION

The seat should never be lowered more than one half turn of the seat bar and the four bolts and washers should always be reinstalled and tightened. These bolts should be checked frequently to see that they are tight. AT NO TIME SHOULD THERE BE LESS CANVAS AROUND THE SEAT BAR THAN SHOWN ON THE ACCOMPANYING SKETCH.

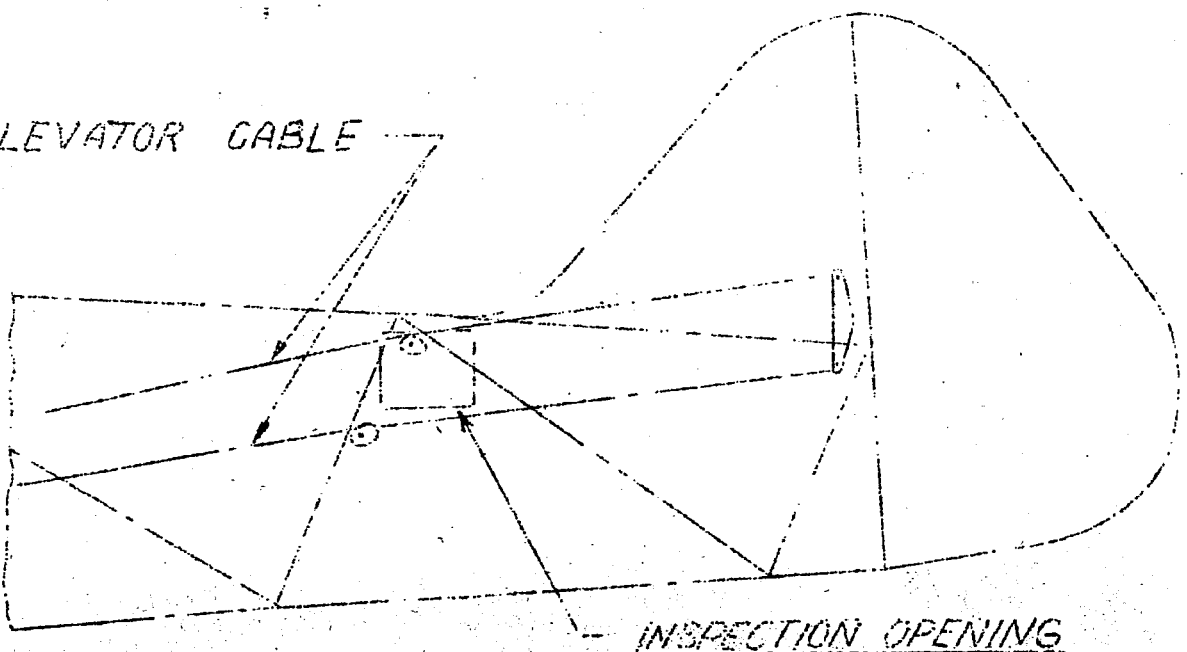
It has come to our attention that there is a possibility of the bushings in the rear elevator control pulleys being too short and not giving the pulley proper clearance in the bracket.

These pulleys are accessible through the inspection openings on the rear of the fuselage, and the location is shown on the accompanying sketch.

Therefore, we are requesting that you immediately replace the present bushings with the two bushings enclosed and return the enclosed card to our factory at your earliest convenience.

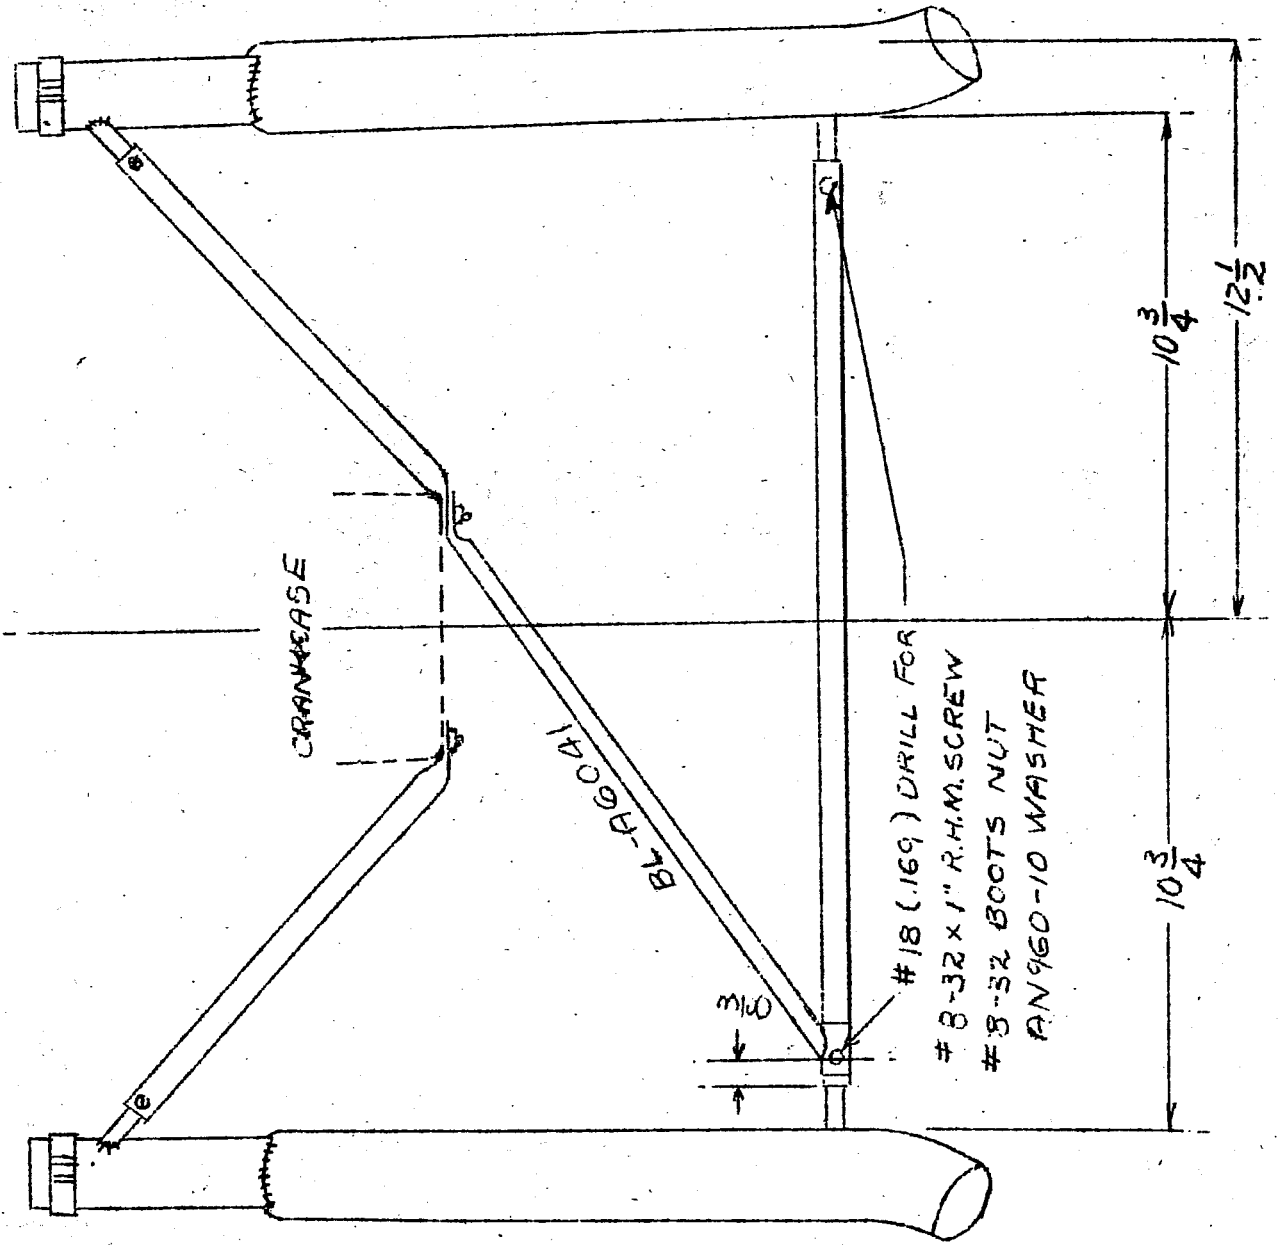
It has come to our attention that the exhaust sleeves on the open cowl Lycoming installations are coming loose from the heads, making it necessary to install new heads or have threaded sleeves inserted in accordance with Lycoming's Bulletin #102.

It has been suggested that this may be due in part to the fact that the lower ends of the exhaust stacks are not anchored even though they are tied together. There is a possibility that during certain rough periods of the engine through oscillation or vibration the lower ends of the stacks may swing and cause the loosening of the exhaust sleeves.

We are recommending the installation of an additional brace from the bracing stud on the bottom of the crankcase on the right side of the engine to the cross tube between the bottom of the stacks where it joins the left stack. This additional brace, we believe, can be made up from the accompanying sketch or can be supplied from our factory at a net price of \$1.00 prepaid.

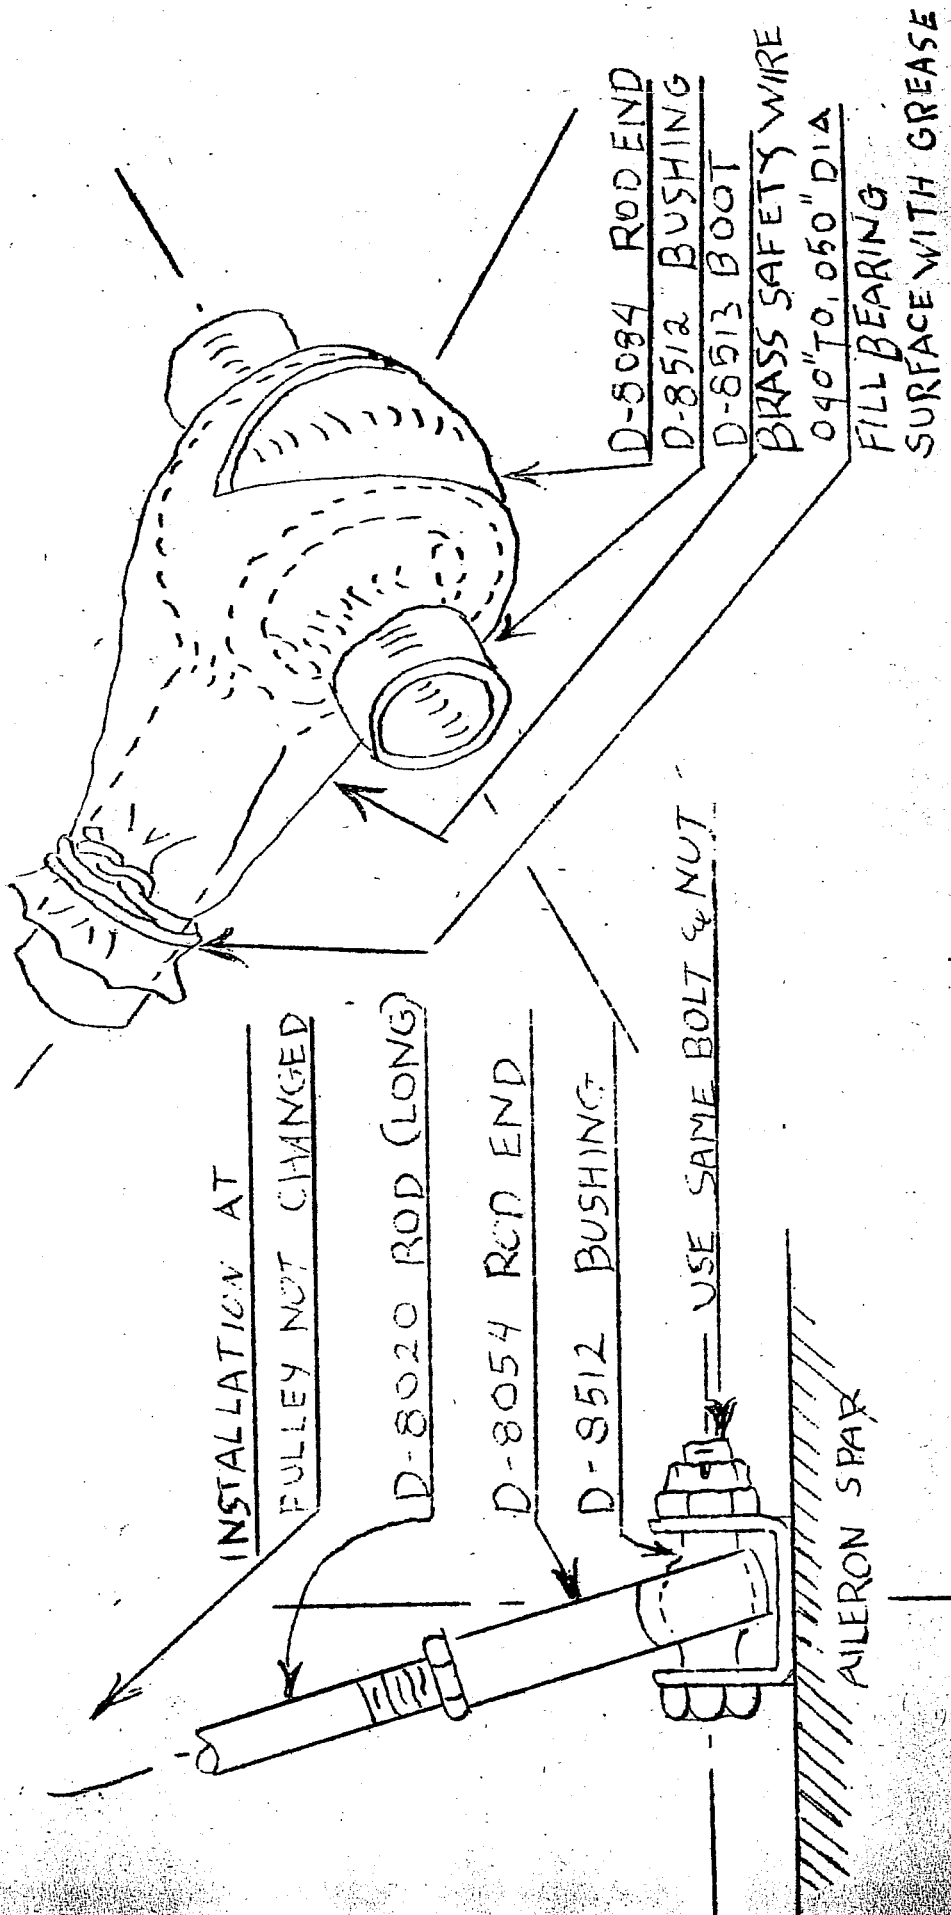
LOCATION AFFECTED: Wing & Aileron, aileron activating link.

PART AFFECTED: Aileron drag link installation.

BOOT SHOULD BE INSTALLED OVER ROD END & BUSHING AS SHOWN TO THE RIGHT BEFORE LINK IS INSTALLED AT AILERON

CHANGE NECESSARY: Remove link from pulley in wing & fitting on aileron control point. Reinstall according to attached diagram using new parts enclosed.

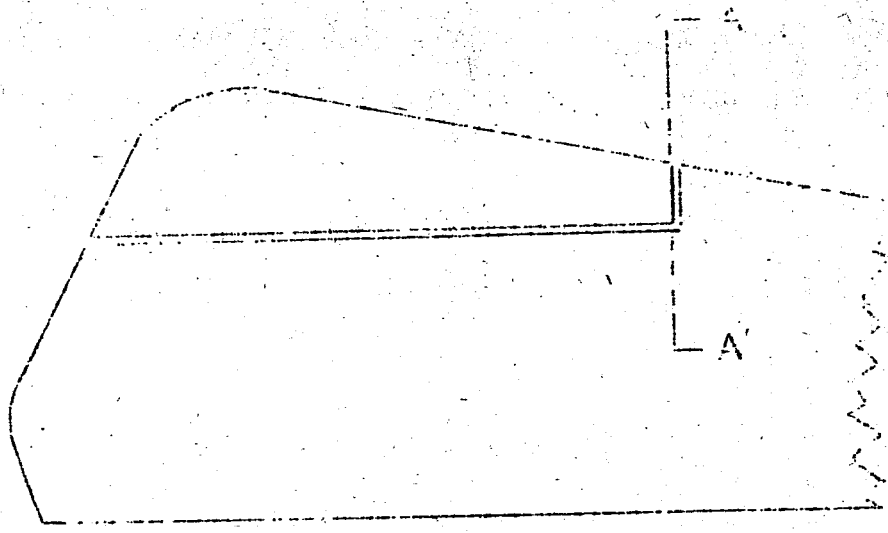
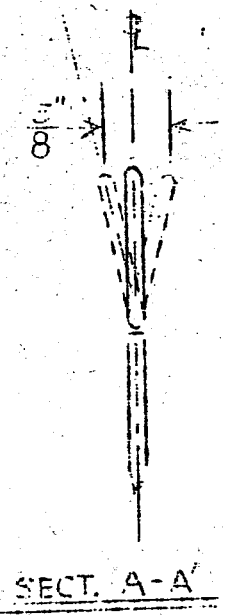
— FIG. 1 —

Reason for Change: Eliminate possibility of flutter in trim tab surface

1. Run tab from extreme "nose down" position to neutral.
2. Grasping the trailing edge of the surface, determine the amount of travel in the tab surface at the trailing edge. (Fig. 1)
3. If this travel is $3/8$ " or less this bulletin has been accomplished, the mechanism is considered satisfactory and the remainder of the bulletin is void.
4. If this travel is in excess of $3/8$ ", remove the inspection plate in the lower surface of the elevator giving access to the trim tab activating mechanism.
5. By moving the tab surface through its angle of play several times, the joints in the system showing a large amount of play can be determined.

6. If selecting and installing new bolts manufactured to the high side of their tolerance does not result in bringing the play of the surface within $3/8$ " as described in sections 1, 2, and 3 above, the parts indicating excessive wear by the play in the joints should be replaced in order to accomplish this.
