Airworthiness Concern Sheet

Make, Model, Series, Serial No.: Taylorcraft, all models equipped with landing gear.

Reason for Airworthiness Concern: Failure of the Main Landing Tie Strut, Part Number B-A51

SERVICE BULLETIN

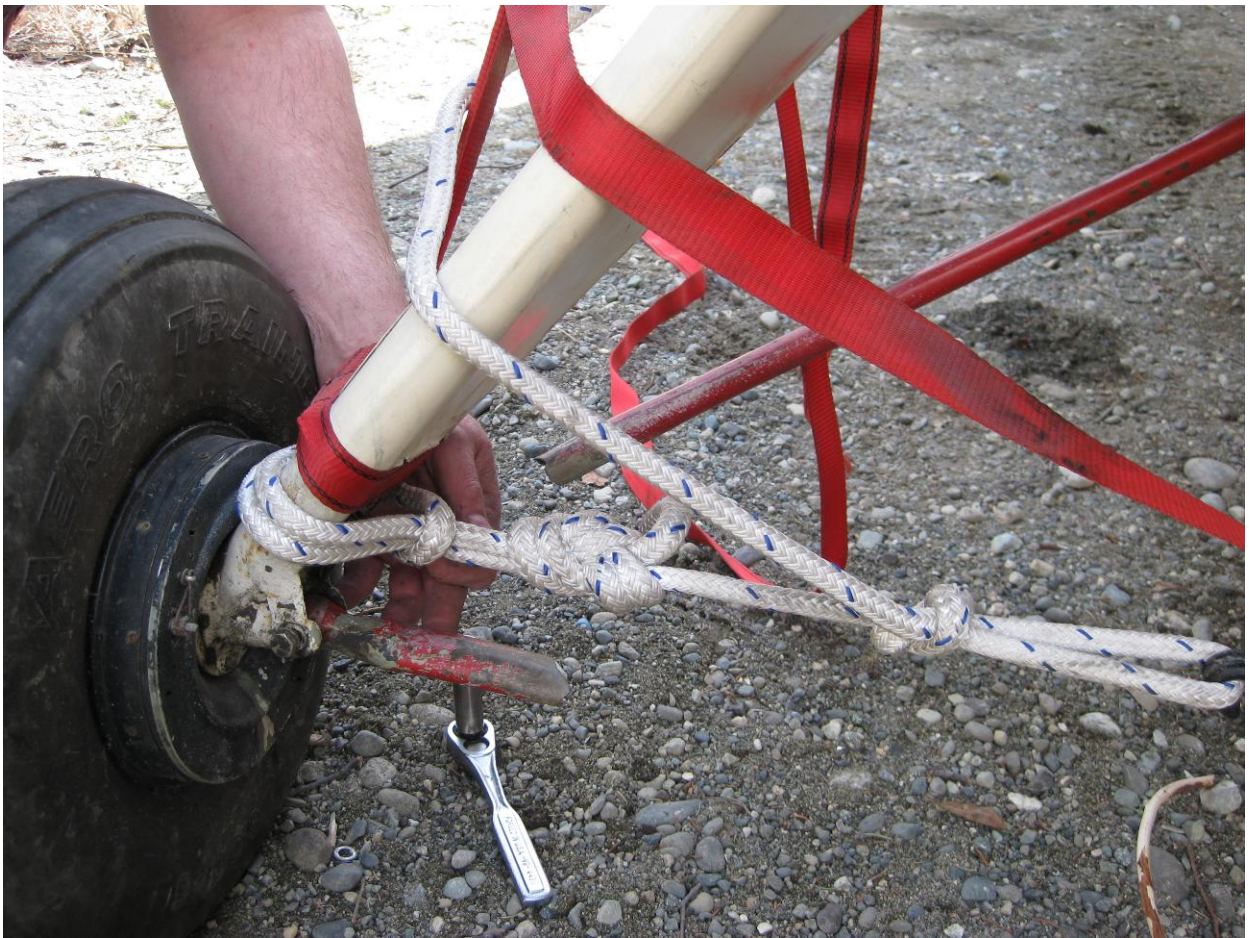
FAA Description of Airworthiness Concern: A Taylorcraft BC-12D right main landing gear failed on landing when the landing gear tie strut broke approximately 6 inches inboard from the wheel. Investigation found the tie strut to be internally corroded and the probable contributing factor to the failure. Pictures of the failed tie strut are attached. Taylorcraft Aviation Corporation Service Bulletin No. 78-001 (attached) requires owners to check the strut drain hole for blockage, and to drill a drain hole if one does not exist.

Failed Tie Strut on RH Main Gear

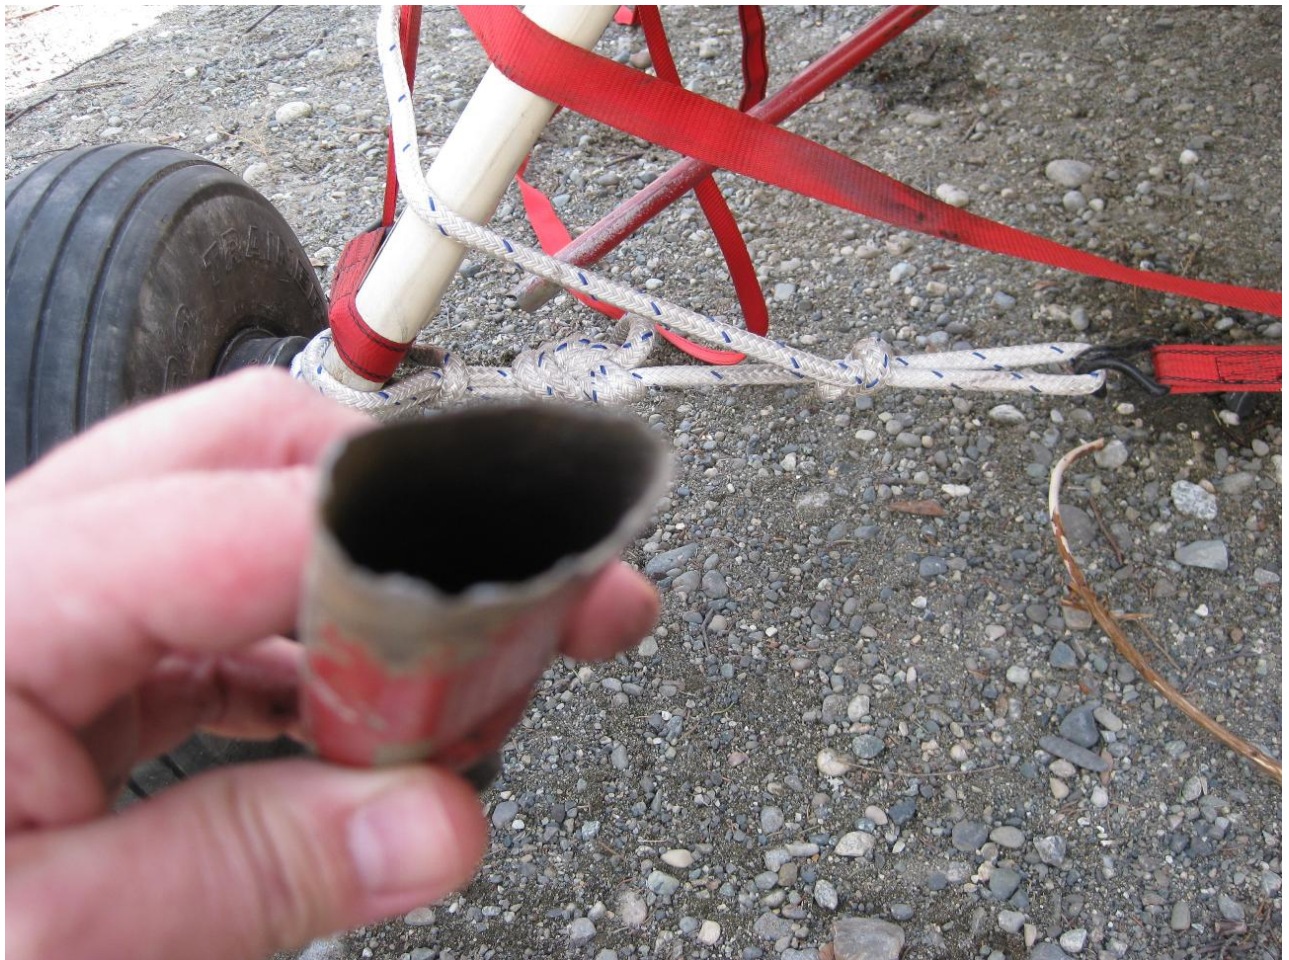
Broken End of Tie Strut (Removed from Aircraft)

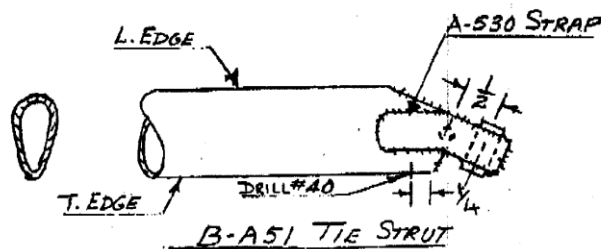
FIG. 1.

Note that drain hole is either located at center of strap (TAC P/N A-530) and/or at trailing edge of tie strut. Only one hole is sufficient for drainage.

(2) If drain hole(s) is (are) plugged, open with suitable means.

(3) If none of the drain holes exist, drill #40 in trailing edge as shown in Fig. 1.
