# CMI A-65, A-75, C-75, C-85, Tappet Inspection

Recommendations for commonly  
occurring in-service observations of  
tappets, Part Number 21608, S21608.  
New and reconditioned articles.

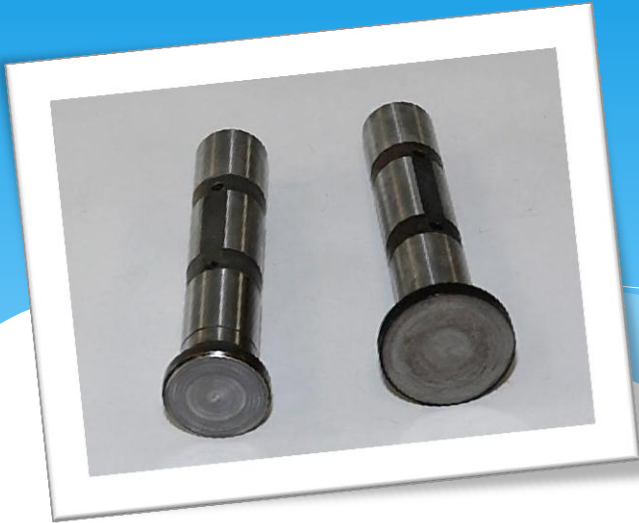
- \* The ratio of head diameter to shank diameter is low, thus the amount of torque that can be applied by the cam to rotate the tappet is very small. This was a design decision made by the OEM. Also related to this ratio is the effect of tappet bore clearance and particulates left over from case work (sand, glass beads, metal cuttings, etc.) to more easily hinder the rotation of the tappet. See fig 1 for a comparison of head sizes between the 21608 and 530851, (used in O-200/300).

Fig. 1 Comparison of 21608 and 530851 head sizes.

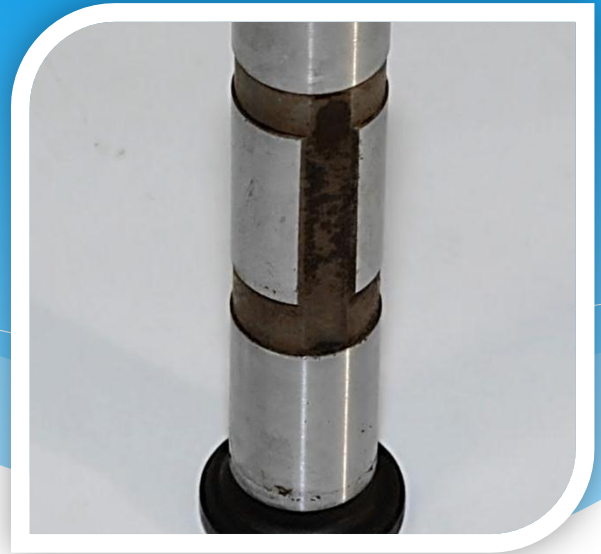
- \* Receiving inspection often finds a large number of 21608 tappets which did not rotate. (See fig 3). Of these, most have evidence on the stems indicating FOD was present in the oil system. (See fig 2).

Fig. 2 Glass beads in oil transfer relief area.

- \* Proper cleaning. We can't stress enough the heroics involved in cleaning the case and associated components. Don't trust anyone in the supply chain. Do this job yourself and be diligent about it. Read everything available on the subject for ideas on how to do this well.

- \* Focus a LOT of attention on oil galleys. Glass beads hide in corners where cross drilling occurs in the case. Remove all galley plugs and utilize the OEM recommended cleaning procedures. Re-install plugs.

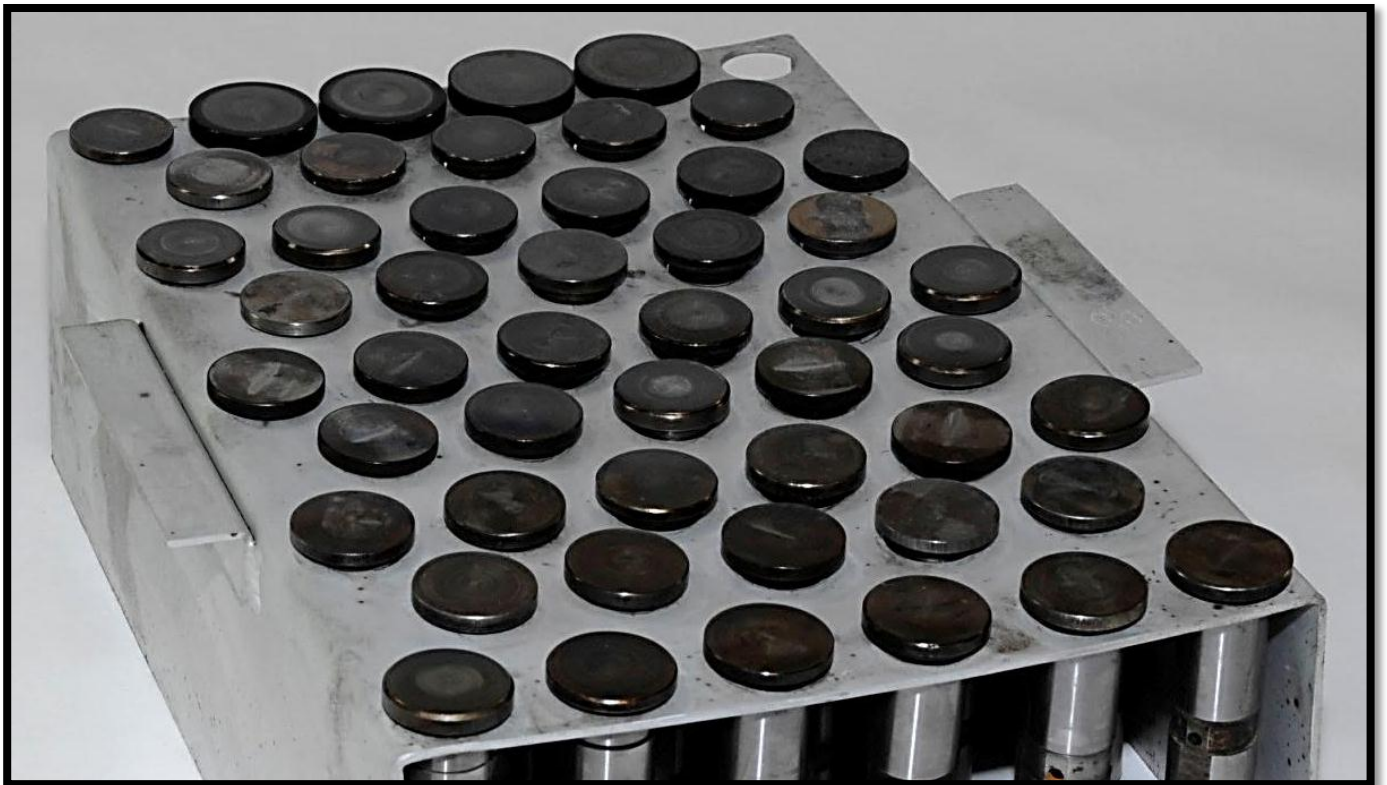
Fig. 3 In-coming lot of 21608 tappets.
