service bulletin

M77-19

SUBJECT: Intake and Exhaust Rocker Arm Identification and Application

AFFECTED: C-75, C-85, C-90, C-125, C-145, O-200 and O-300 Series Engines

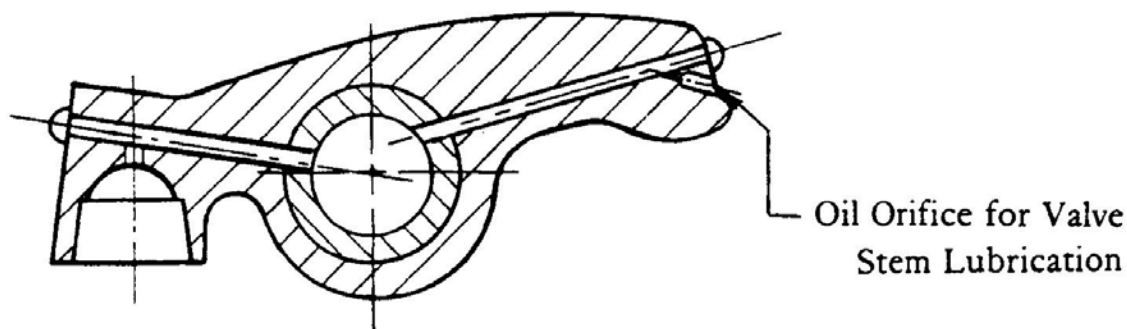
FIGURE 1

We wish to point out that intake rocker arms, Teledyne Continental Motors part number 639614, do not have an oil orifice drilled in the valve stem end of the rocker arm as does the exhaust rocker arm, Teledyne Continental Motors part number 639615. The oil orifice as evident in Figure 1 provides needed lubrication to the exhaust valve stem during engine operation. Caution notes regarding this subject should be placed in your Teledyne Continental Motors Overhaul Manuals Form Number X-30013 dated July, 1970, or earlier and Form Number X-30010 dated April, 1973 or earlier.

Teledyne Continental Motors part number 639615 exhaust rocker arm.
