# Airworthiness Concern Sheet

**Make, Model, Series, Serial No.:** Taylorcraft, all models equipped with landing gear.

**Reason for Airworthiness Concern:** Failure of the Main Landing Tie Strut, Part Number B-A51

SUBJECT: Drain hole - landing gear tie strut.

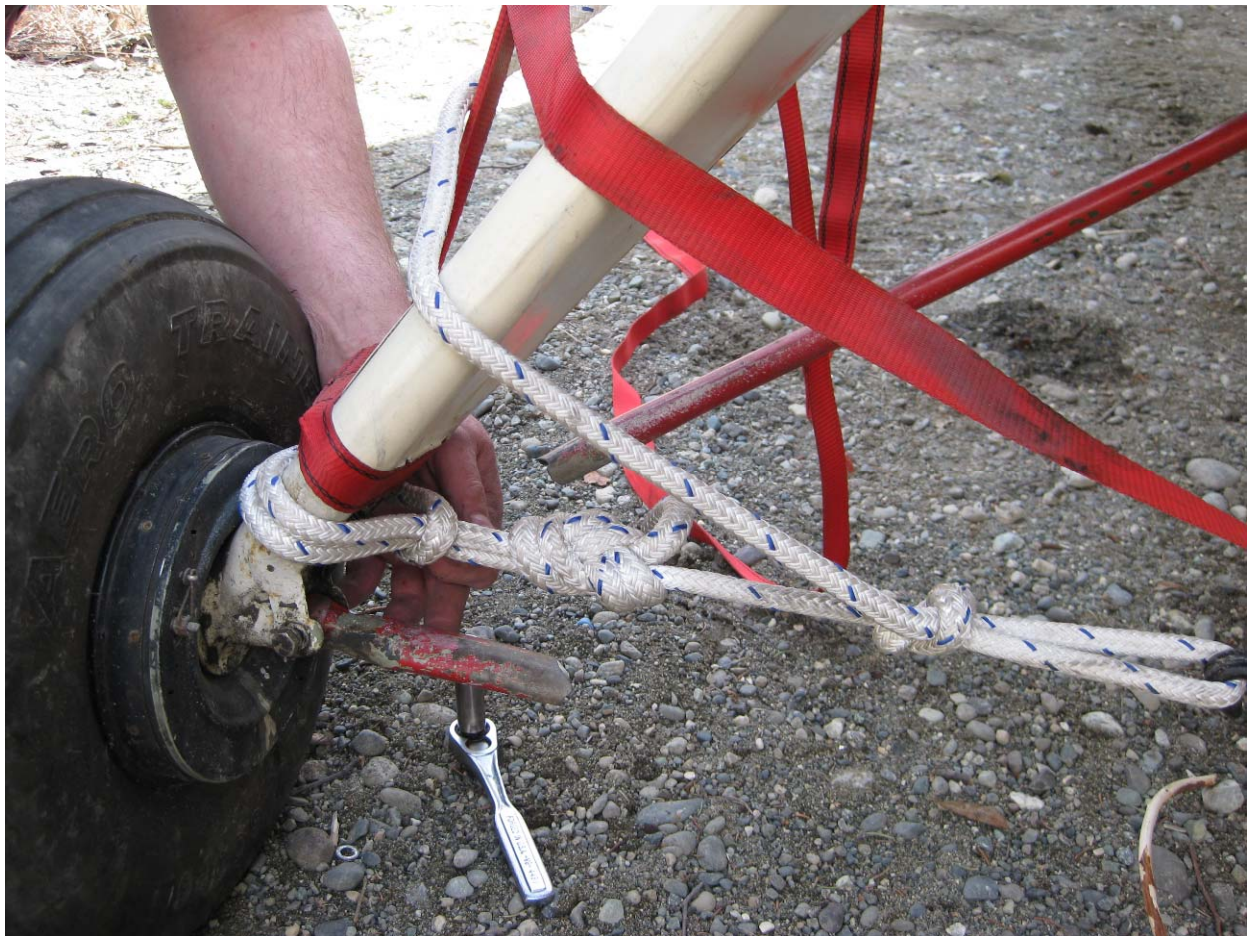
**FAA Description of Airworthiness Concern:** A Taylorcraft BC-12D right main landing gear failed on landing when the landing gear tie strut broke approximately 6 inches inboard from the wheel. Investigation found the tie strut to be internally corroded and the probable contributing factor to the failure. Pictures of the failed tie strut are attached. Taylorcraft Aviation Corporation Service Bulletin No. 78-001 (attached) requires owners to check the strut drain hole for blockage, and to drill a drain hole if one does not exist.

Failed Tie Strut on RH Main Gear

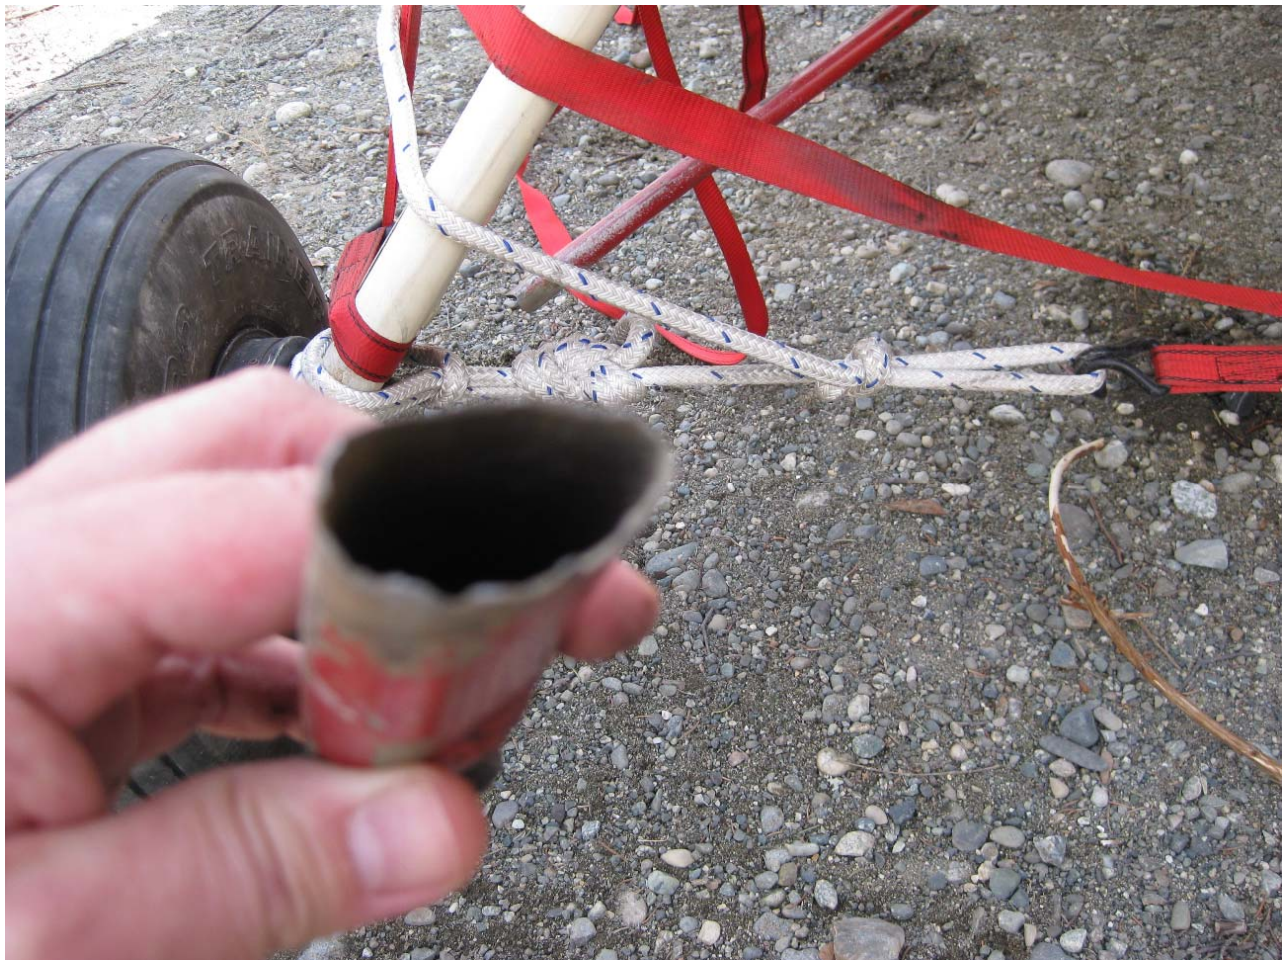
Broken End of Tie Strut (Removed from Aircraft)

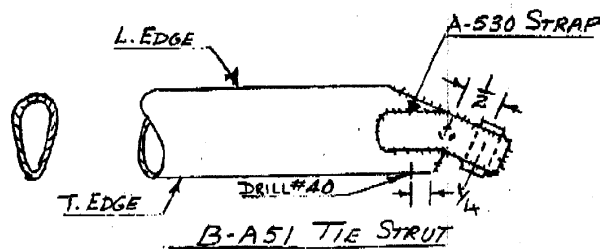
FIG. 1.

Note that drain hole is either located at center of strap (TAC P/N A-530) and/or at trailing edge of tie strut. Only one hole is sufficient for drainage.

(2) If drain hole(s) is (are) plugged, open with suitable means.

(3) If none of the drain holes exist, drill #40 in trailing edge as shown in Fig. 1.
