# SERVICE BULLETIN

Service Bulletin No. 2007-002  
Date: November 8, 2007

Inspection of: wing strut attach fitting part number A-A11 for cracks or corrosion.

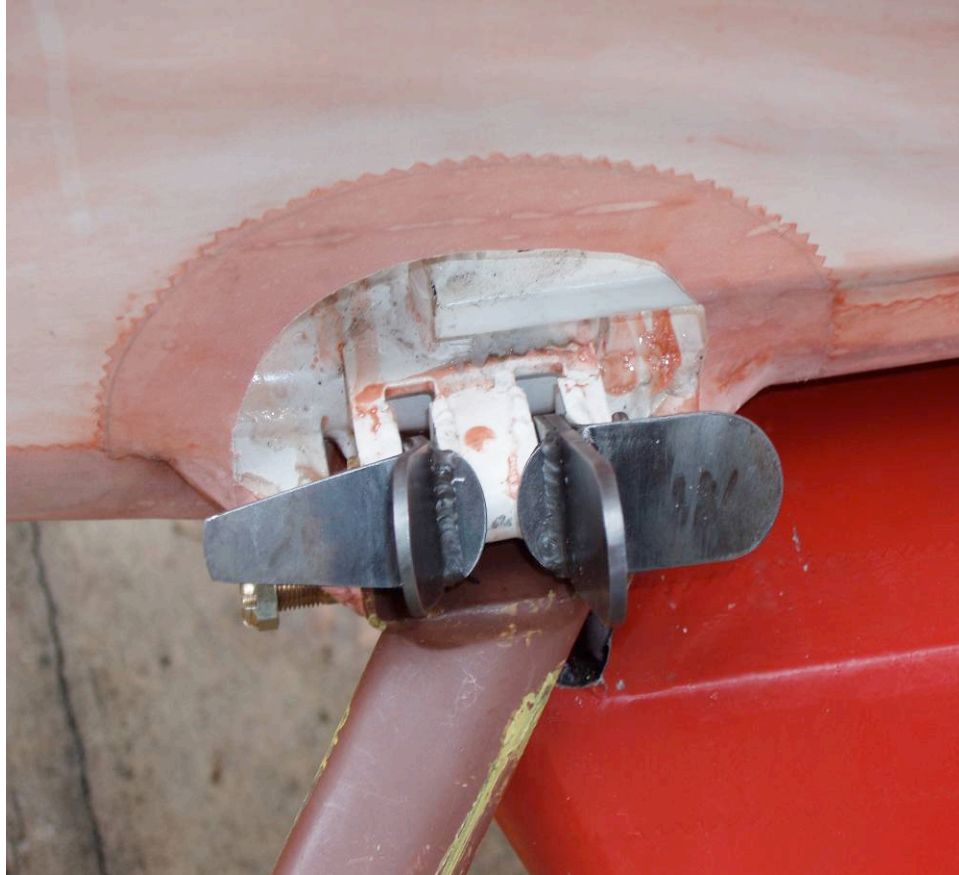
**Fig. 1 Cut Fabric as Shown (Strut Ends Only Shown for Clarity)**

1. Remove landing gear to fuselage fairings L/R side.
2. Remove any aircraft fabric that is attached to the actual lower wing strut attach fitting. Use a razor to carefully cut and remove the fabric from the lower fuselage longerons up and around the strut attach fitting, leaving a minimum 1/2" gap around the strut attach fitting. Take care not to scratch the protective coatings or primer (see photo #1).

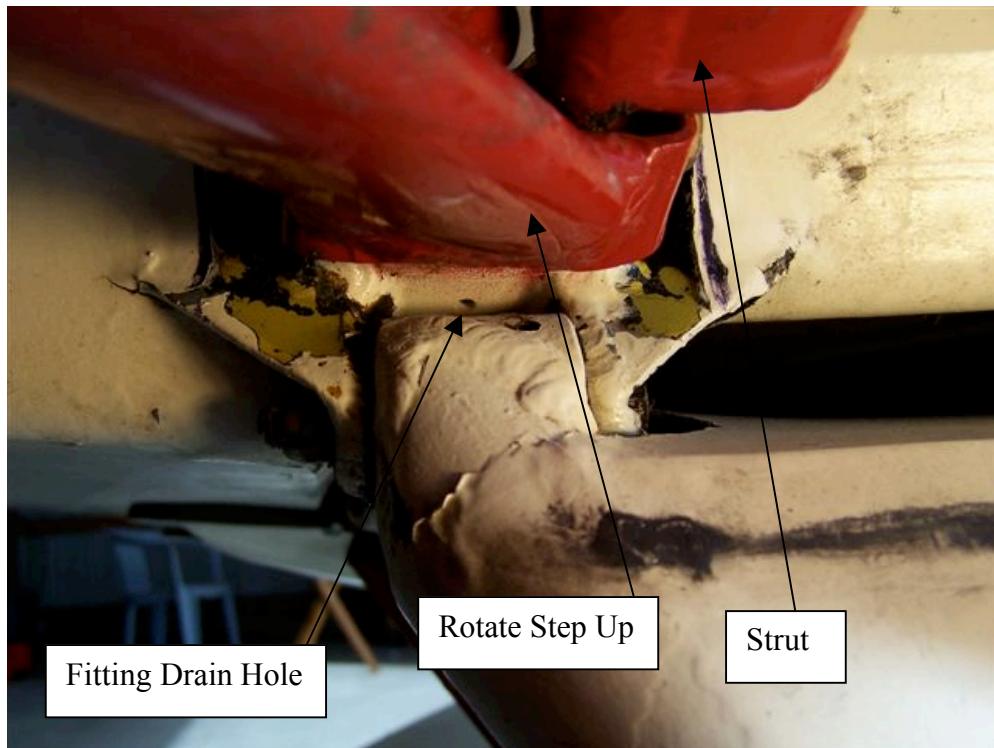
**Fig. 2a Rotate Step Upward to Expose Fitting Lower Surface and Drain Hole**

3. Remove all dirt, mud, fabric scraps, fabric glue residue, and any other foreign debris from external and/or internal surfaces of the fitting.
4. Lift up and rotate the step to allow a thorough visual inspection of the underside of the attach fitting. Use a strong light source and a small inspection mirror. Verify that the **drain hole** is open and clean using suitable metallic probe (see photos #2a & 2b).

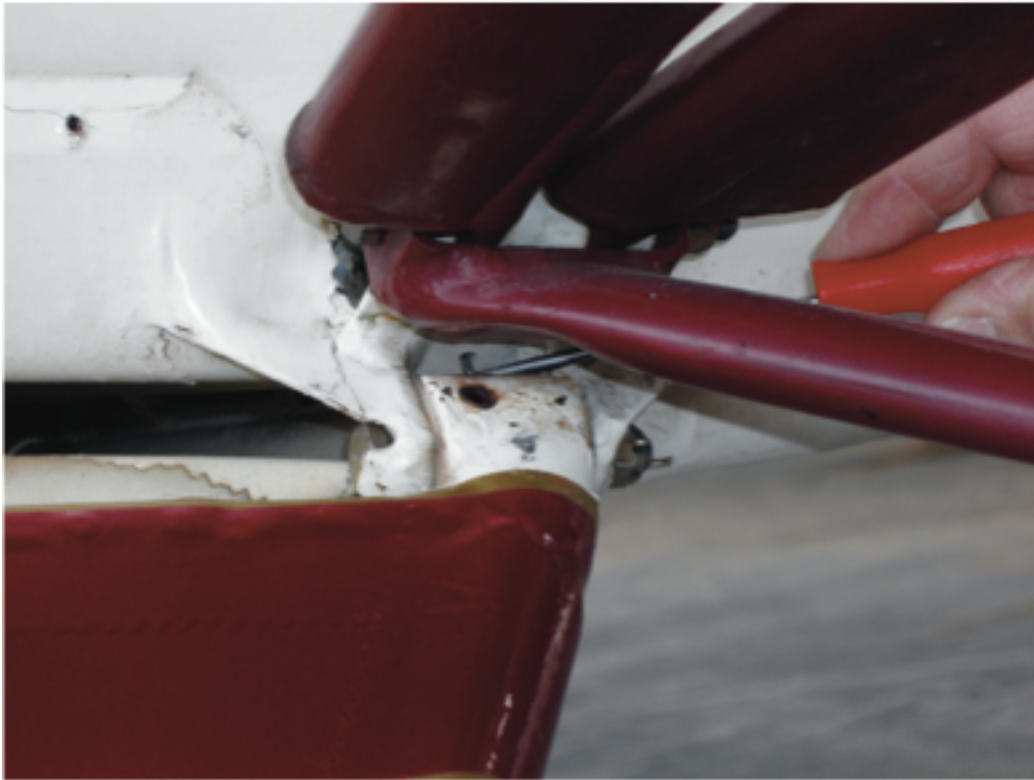
**Fig. 2b Verify Drain Hole is Open**

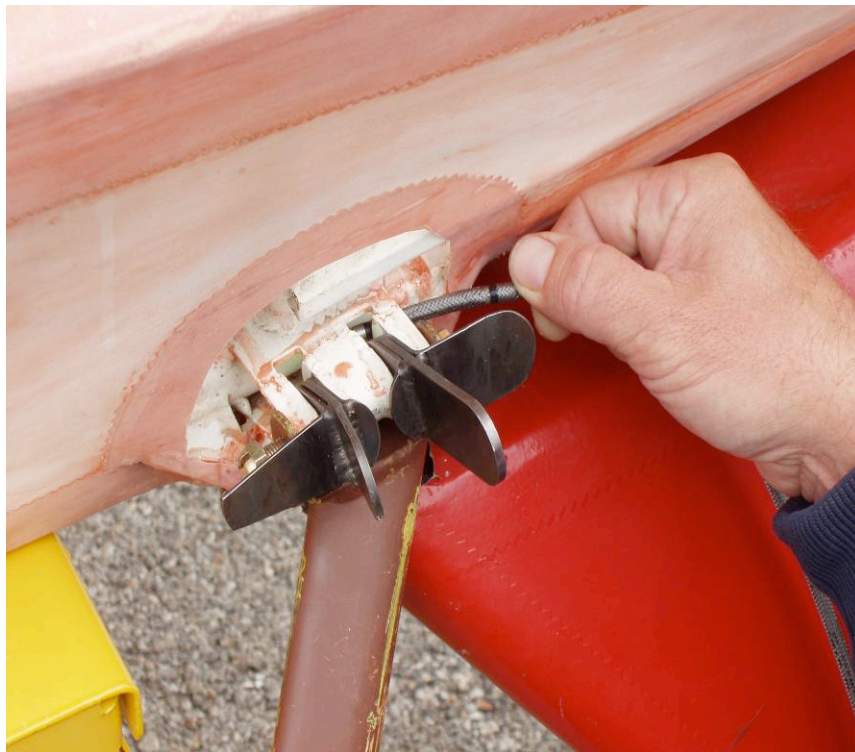
- Pay particular attention to the inner lug area between the two struts (see photo #3 & 4) (Reference AC 43.13-1B, Chapter 5, Section 2 for visual nondestructive inspection).
7. If any signs of blistered paint, cracks or corrosion are discovered during this inspection, perform Part 2 of these instructions prior to further flight.
  8. Touch up any damaged or missing paint or protective coatings with primer and paint in accordance with Part 2.
  9. Repair the area around the fitting with an aircraft fabric patch, using aircraft fabric, coatings, and chemicals approved for the fabric system used in the aircraft. This fabric repair shall not extend over, cover, or restrict future visual access to the fitting. No ends or clippings of the new fabric repair are to be “tucked” into the fitting or cover up the drain hole.
  10. Reinstall L/R side landing gear to fuselage fairings.

**Fig. 3 Borescope Inspection (Strut End Fittings only shown to enhance view)**

7. When the clean bare metal has been exposed, make a further visual inspection using a ¼” **borescope** to determine the severity of any pitting, loss of material, cracks, or other defects (see photo #3).

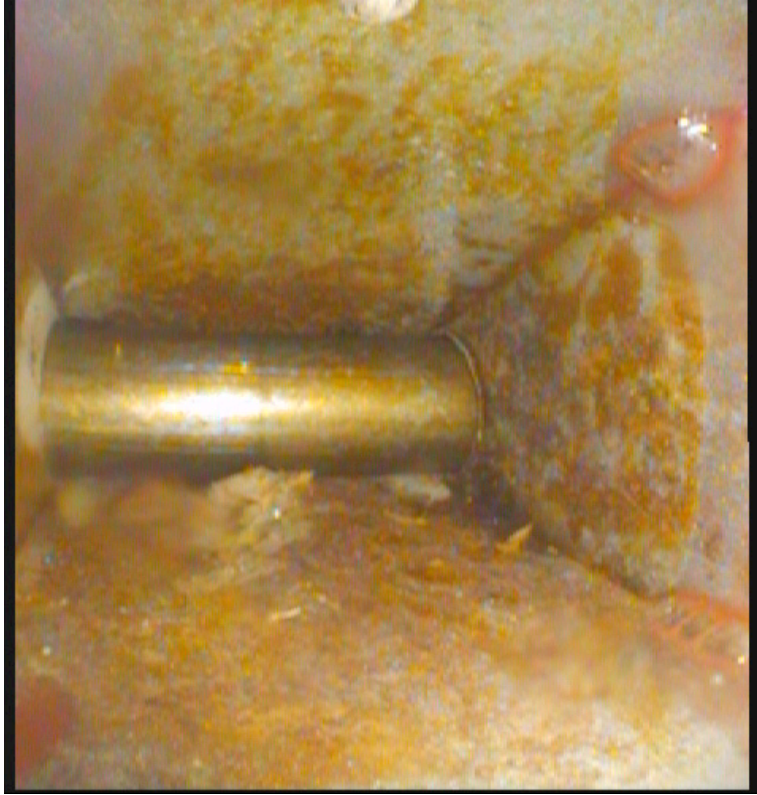
**Fig. 4 Borescope View - Inside Center Lug Cavity**
