Air Transportation Safety Investigation Report A19C0026

WING LIFT STRUT ASSEMBLY FAILURE AND COLLISION WITH TERRAIN

Piper J3C-65, C-FLDQ (privately registered)
Snowshoe Lake, Ontario
30 March 2019

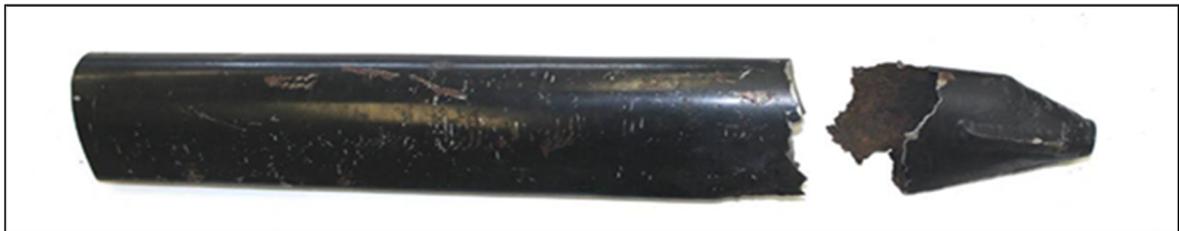
An inspection of the airframe at the site revealed that the left main spar wing lift strut assembly separated near the lower fork end attachment (Figure 2). A visual examination of the wing lift strut assembly revealed excessive corrosion in the area of the separation. The failed wing lift strut assembly was sent to the TSB Engineering Laboratory in Ottawa, Ontario, for further analysis.

Figure 2. Damage on the upper half of the left main spar wing lift strut assembly (Source: TSB)

The TSB Engineering Laboratory's analysis of the failed wing lift strut assembly revealed that the failure was initiated by excessive corrosion and thinning of the load-bearing wall inside the wing lift strut, followed by fatigue, and eventual overload failure.

The TSB Engineering Laboratory conducted further examination of the failed wing lift strut assembly and completed the punch test inspection prescribed in the MSB 528D, which states that if the punch test procedure creates a perceptible dent⁵ using a punch tester,⁶ then the wing lift strut assembly metal is corroded beyond specified limits and the wing lift strut assembly is to be replaced before further flight. If no perceptible dent is evident then the wing lift strut assembly can remain in service. Representatives of Piper Aircraft Inc. and Transport Canada (TC) observed the tests. Several punch tests were completed in areas immediately surrounding, and further from, the fractured area on both the lower and upper halves of the failed wing lift strut assembly.

The alternative inspection method described by the AD is the ultrasonic method. Whereas the typical thickness of an exemplar wing lift strut assembly wall is between 0.034 and 0.041 inch, the ultrasonic inspection procedure specifies that wall thickness measurements of 0.024 inch or less require replacement of the wing lift strut assembly prior to further flight. Although an ultrasonic inspection was not completed on the failed wing lift strut assembly, an examination using a scanning electron microscope was accomplished to take accurate measurements of wall thickness. This examination determined the following:

- the heavily corroded area on the lower half of the failed wing lift strut assembly had a remaining wall thickness between 0.002 and 0.019 inch, well below the required minimum. Punch tests applied to this area revealed one perceptible dent.
- the corroded area of the upper half of the failed wing lift strut assembly had a remaining wall thickness between 0.021 and 0.031 inch; therefore, some areas were below the required minimum. Punch tests applied to these areas did not produce any perceptible dents.

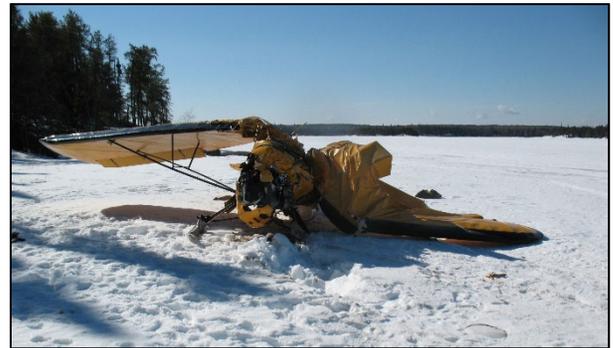
The aircraft struck the frozen surface of the lake in an inverted position and at a shallow angle, with a high rate of vertical descent and at high forward speed. The aircraft came to rest in an upright position approximately 125 feet from the initial point of impact, facing north (Figure 1).

Figure 1. Wreckage site (Source: TSB)
