## **Model B - Maintenance Guide and Critical Inspection Points**

**Rev. A**

**Date: 24October 2010**

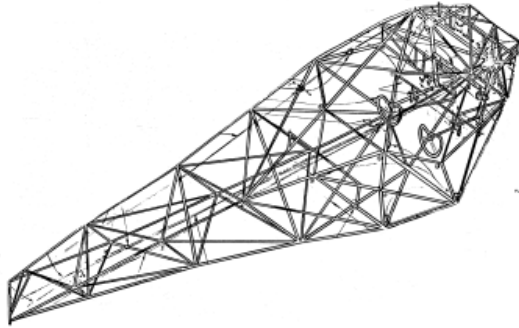
- Fiberglass / aluminum skin - for deterioration, distortion, other evidence of failure, and defective or insecure attachment of fittings.

Particular to the Taylorcraft B Model is the boot cowl and lower belly area behind the firewall. The belly sheet metal skin is riveted on using blind type fasteners that have the propensity to work loose and fret. The skin itself can 'oil can' and crack at attach points and around rivets.

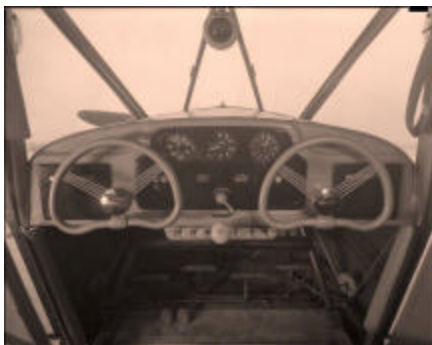
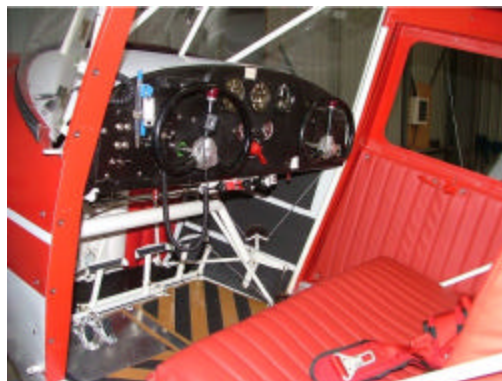
Crazing on the front windscreen is common directly behind the header tank filler cap. This is often caused by overfilling the header tank with the wing tanks during flight and spraying fuel onto the windshield in this area. The windshield radius's at the wing roots is also a common area for stress fatigue and cracks.

The aileron pulleys on the control yoke assembly often times are worn and the pulley will be rotating on the bushing. Actuate the ailerons and pay close attention to the pulleys and cables. Frozen pulleys are also quite common.
