SHOCK CORDS

Know when to change them

ARTICLE AND PHOTOS BY H.G. FRAUTSCHY

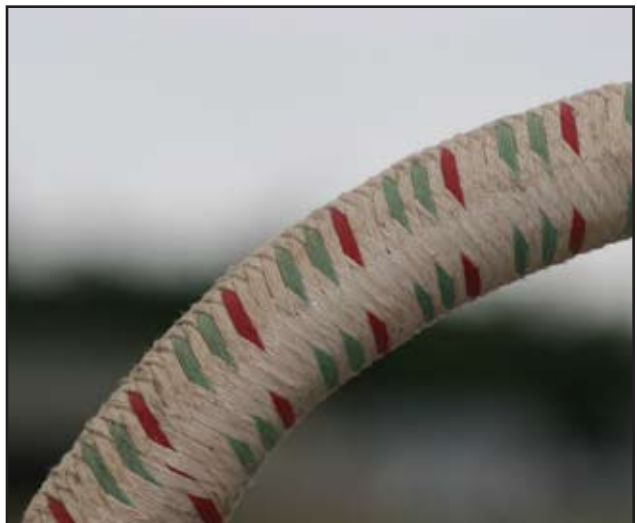
A serviceable cord should have a smooth outer covering, with no bumps or disruptions to the woven cover. This one looks good, but age and repeated landing cycles have taken their toll.

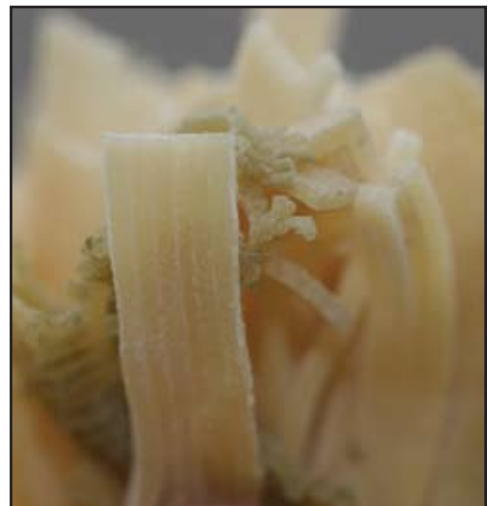
No, it's not some new exotic pasta dish, or an undiscovered sea creature. The outer rubber strands show signs of environmental aging, as ozone and airborne contaminants (including engine exhaust chemicals) attack the rubber. You can see how the inner strands are less affected. Again, this shock cord didn't appear to be excessively worn when viewed from the outside; the damage was only obvious once the covering was cut away.

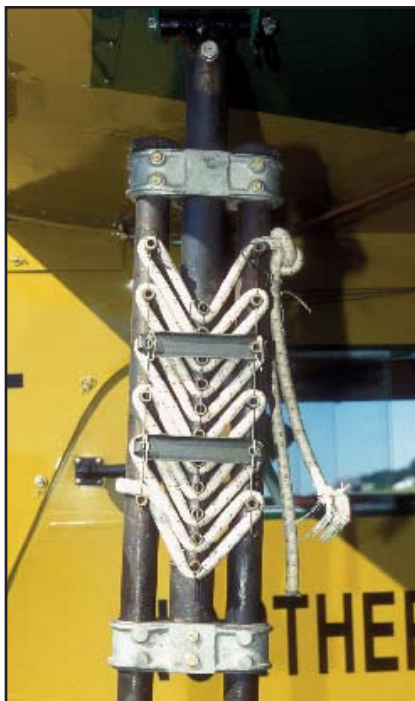
Some aircraft use multiple shock cords. This is the upper end of the landing gear of a Fokker Super Universal. A similar herringbone arrangement was used on the Ryan NYP, Spirit of St. Louis.
