# TYPE CLUB NOTES

## CARE AND REPAIR OF THE AAF TYPE A7 MAGNETO SWITCH

STEVE KROG AND BOB GEHRING  
FROM THE CUB CLUB NEWS

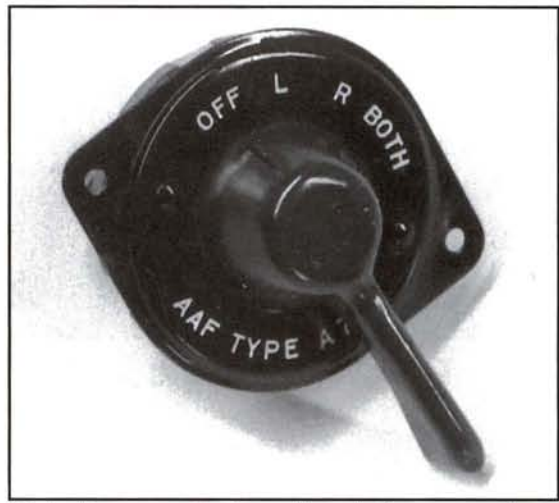
Virtually every single-engine airplane manufacturer has used the AAF Type A7 magneto switch since the early 1940s.

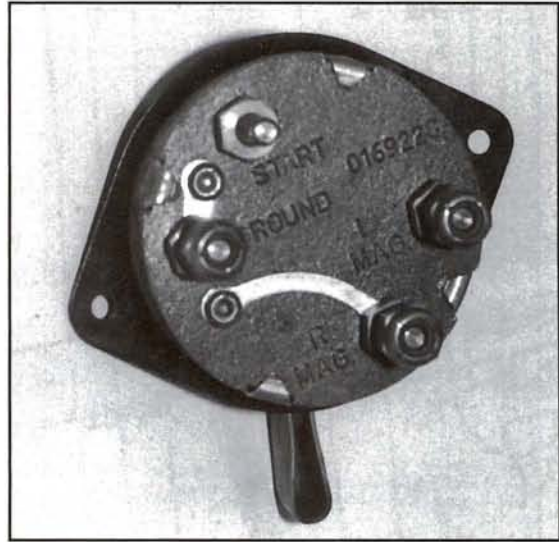
The A7 mag switch backplate is clearly marked as to which terminal post is the "Ground," Mag (Left) and Mag (Right).

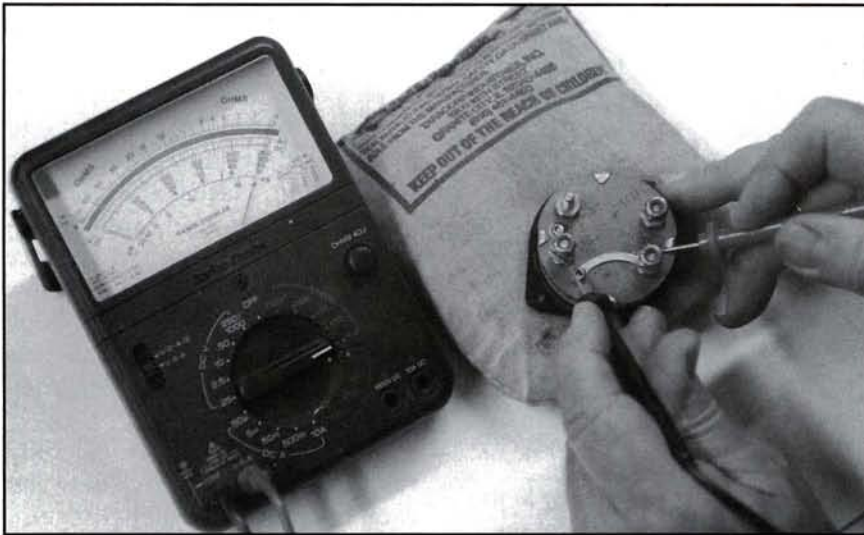
**In this photo the mag is in the "Off" position and the Right mag circuit is being tested. The ohmmeter needle shows full deflection to the right or zero indicating the mag switch is working properly in this position.**

Turn the mag switch to the "Off" position and place one Ohmmeter probe in contact with the "Ground" post and the other probe in contact with the "Left" post. If the switch is functioning properly, the ohmmeter should "zero out" or have full needle deflection to the right of the scale. Repeat the test with one probe in contact with the "Right" post. Again, if the needle deflects to zero, the mag switch, at least in the off position, is working properly in that the two circuits are shorted to ground and will not let the mags fire.

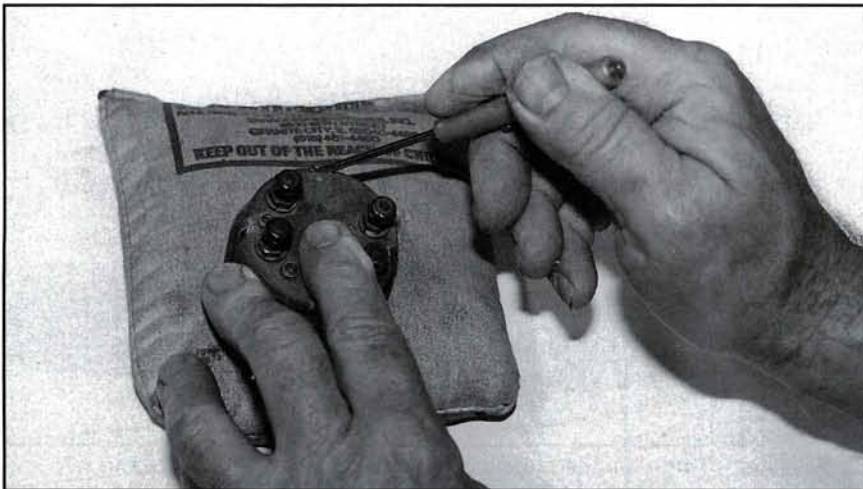
**Using a small flat blade pocket screwdriver, carefully open each of the four retaining tabs holding the fiber backplate.**

Disassembly of the mag switch is quite simple but it does take a bit of patience. Using a small pocket flat blade screwdriver, carefully pry up the four metal tabs. Do not bend them all the way to a vertical position; just open them far enough to lift the hard fiber backplate off the switch.

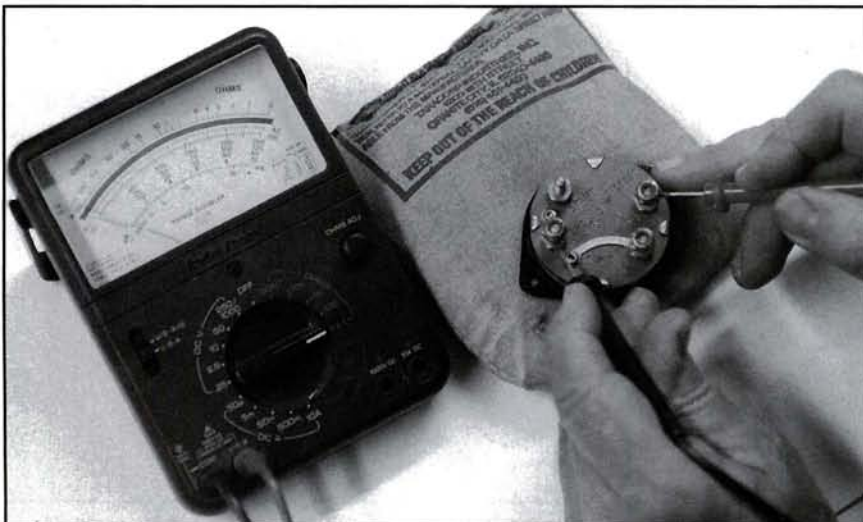
**This photo shows the left mag circuit being tested with the mag in the "Left" mag position. The ohmmeter shows no needle movement, indicating the circuit is "open" and working properly.**

Now, turn the mag switch handle to the "Both" position. Then place one ohmmeter probe in contact with the "Ground" post and the other in contact with the "Left" post. If the mag switch is functioning properly, the ohmmeter needle should not move. The circuit is "open" and would permit the Left magneto to generate a spark if the engine was turned over. While continuing to hold one probe in good contact with the "Ground" post, move the other probe to the "Right" post. (NOTE: Ground, Left and Right are clearly imprinted on the outer back panel of the mag switch.) Again, if the switch is working properly, the ohmmeter needle should not move.

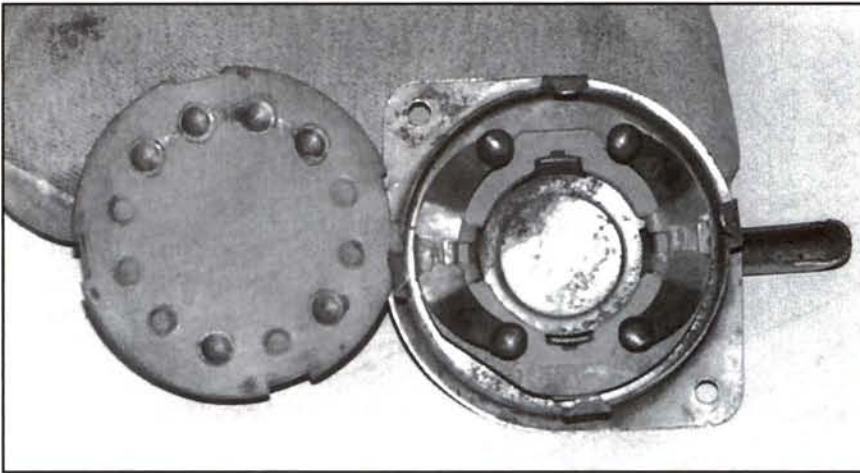
With the backplate removed, the dirt and corrosion are seen clearly in the brass indents and the dirt or copper track is visible between each of the brass indents.

Once you remove the backplate, carefully examine the brass indents. You'll note that each is probably tarnished or even corroded, and there will be a distinct copper track running between each of the indents. The indents need to be thoroughly cleaned and the copper track needs to be removed.

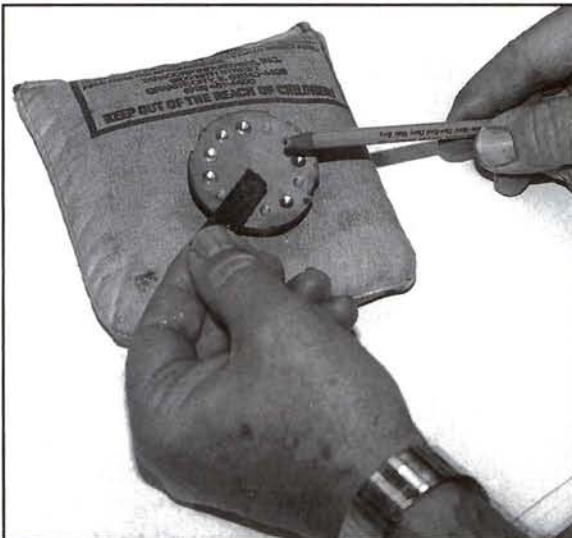
Use a dull pointed wooden pencil and a small piece of a 3M Scotchbrite pad to clean the brass indents.

Break the lead tip off the pencil so that it has a dull pointed end that will fit into the contour of the brass indent. Place the Scotchbrite pad over the indent, apply pressure with the pencil and rotate back and forth. After only a few strokes, the brass indent will look as good as new. Repeat this process until you've thoroughly cleaned each indent.

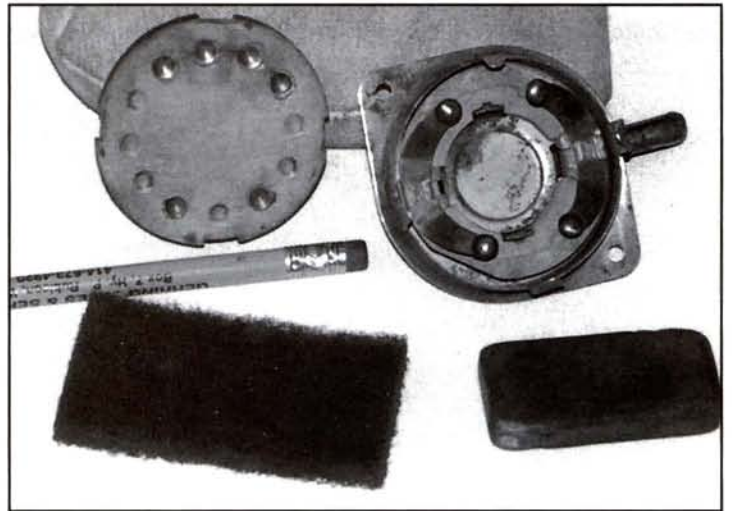
Three simple cleaning tools are needed to restore the A7 mag switch: a wooden pencil, a small piece of 3M Scotchbrite, and either an ink or stainless steel eraser.

Cleaning the backplate requires three simple items: a wooden pencil, a small piece (approximately 1-by-2 inches) of 3M Scotchbrite scouring pad, and either an old-fashioned ink eraser or a stainless eraser. Stainless erasers are available from any good welding supply shop. It is used for polishing out

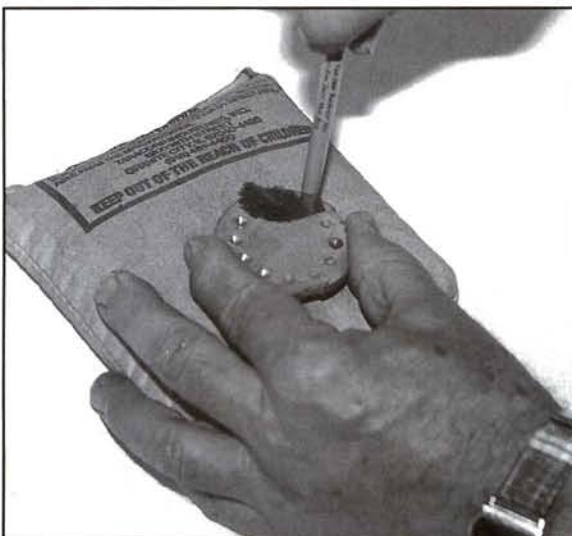
Using the pencil and Scotchbrite pad, apply pressure and rotate in each of the brass indents to clean any impurities and corrosion.

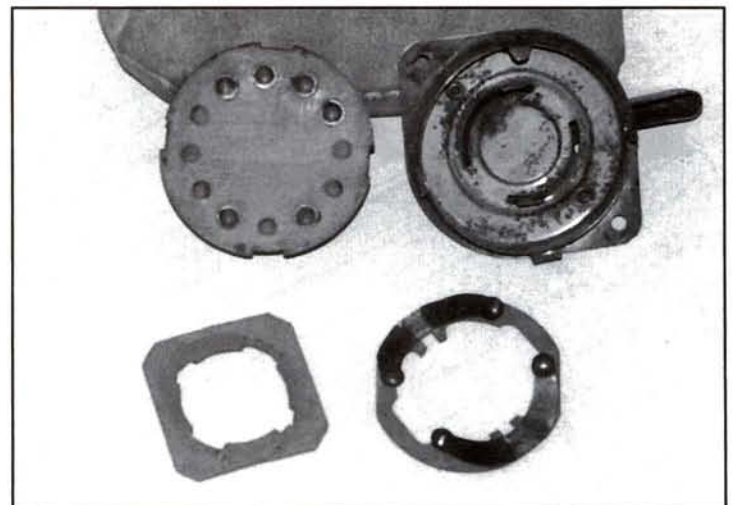
All four components of the A7 mag switch have been disassembled as shown in the photo. There is no need to remove the square spacer, but if you do, align the slotted openings with the two metal tabs when reassembling.

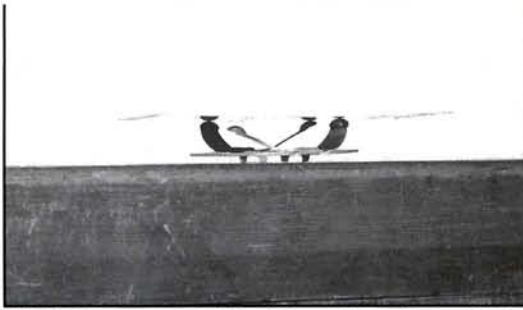
With the copper tabbed ring placed on a flat surface, place a piece of flat material over the tabs to assure they are evenly aligned. Note in this photo that one tab has been bent downward and is not making contact with the flat material. It will need to be carefully bent upward until it too makes even contact with the flat surface.

Now place the copper tabbed ring on a flat surface with the tab side up. Place any flat piece of material, aluminum, cardboard, etc., on top of the tabs. Carefully look at the tabs and make sure that each makes contact with the flat surface. If one or more tabs do not make contact, carefully bend them up until all four tabs make equal contact.

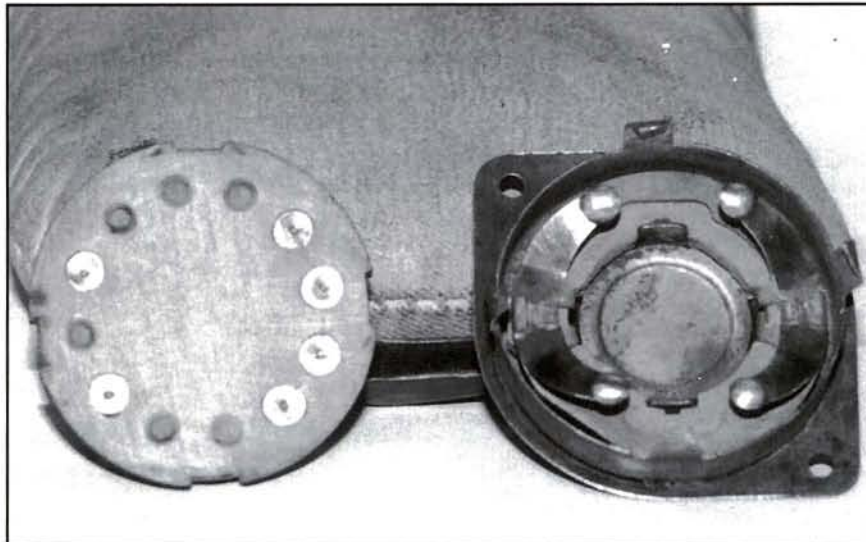
Carefully clean the copper tabbed ring and the fiber backplate with lacquer thinner. The copper tabbed ring fits in either of two positions.

Next, thoroughly clean the entire copper tabbed ring with lacquer thinner, removing all fingerprints, dust, etc.

You're now ready to reassemble the mag switch. Place the copper tabbed ring in the mag-neto housing with the copper tabs pointing out. There are two tabs on the copper ring for alignment in the housing. It can be correctly placed in either of two positions and either is correct. With the mag switch handle positioned in either the "Off" or "Both" position, align the tabs on the copper ring with the handle.

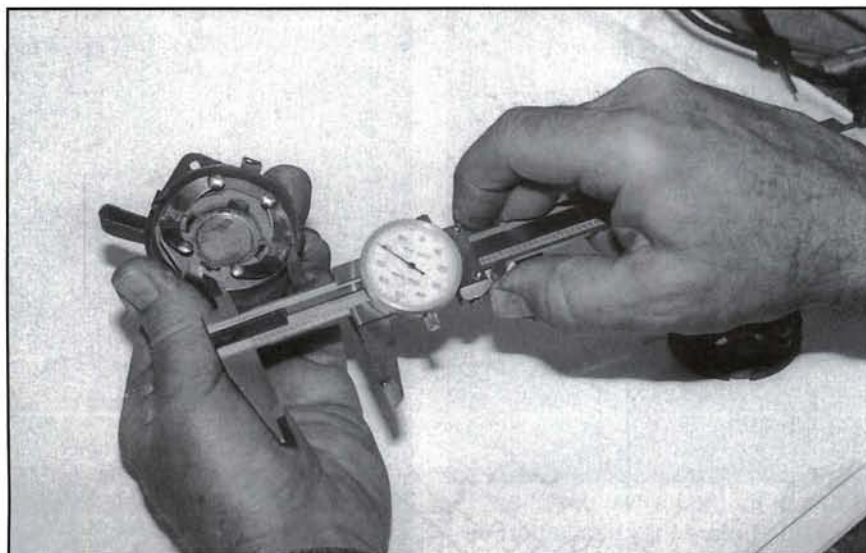
The distance between each tab is slightly different so as to assure that the backplate can only be reassembled in one position.

You can now place the fiber backplate back on the mag switch housing. Carefully rotate the backplate until the four slots align with the four tabs. There is only one position where it is correctly aligned, as the separation between each tab on the housing is different. Take your time and continue to rotate the backplate until it aligns exactly.
