Checking the landing gear hole alignment on the holes that attach the landing gear to the fuselage. If these holes are out of alignment with each other the gear attachment bolts can be difficult if not impossible to install.

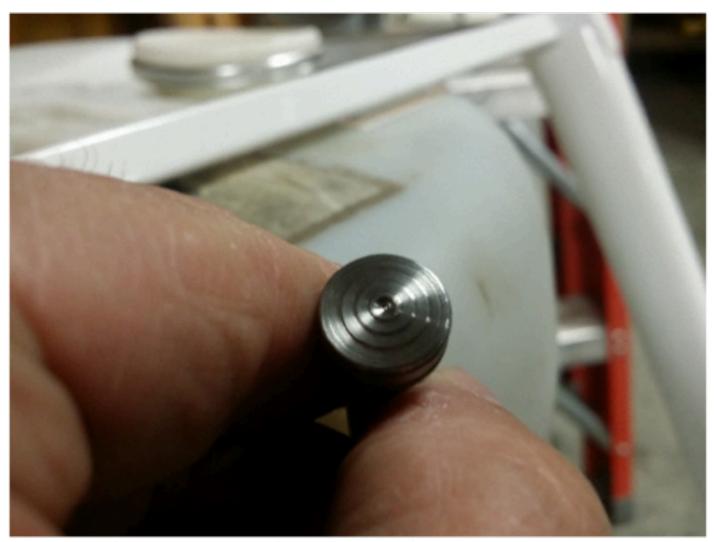
Stepped alignment pin helps indicate alignment error. Pin OD .500" accurately machined to snuggly fit inside the 3/8" gear to fuselage attachment hole.

Note: The laser attachment device must be constructed/calibrated to ensure the laser beam is parallel with and concentric to the hole bore being checked.

By placing this pin into the hole and placing the laser attachment device in the opposite gear attachment hole the difference in alignment between these holes can be determined.

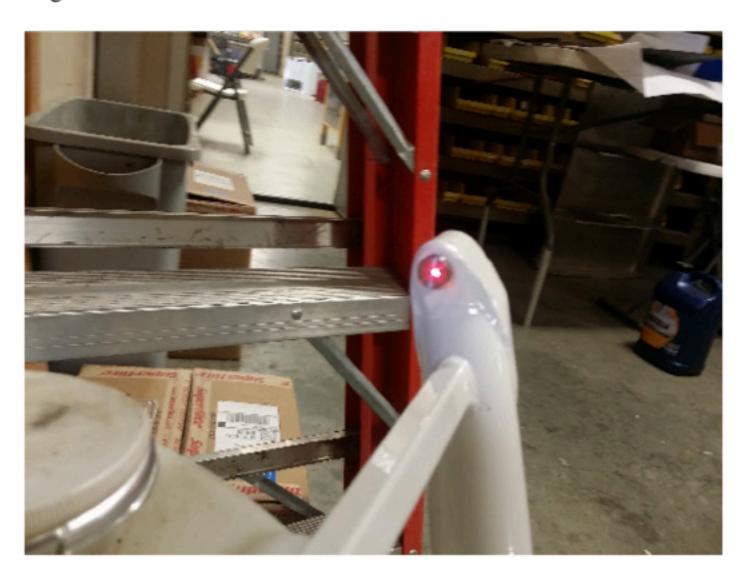
Here, the laser attachment device placed in front gear leg attach hole of the left landing gear pointing aft to the alignment pin in rear gear leg hole. This provides a view of an alignment that would be "good".

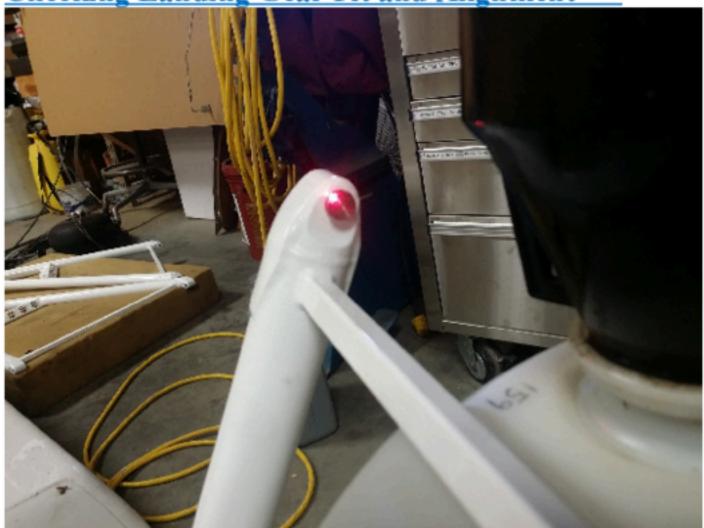
Laser attachment device placed in rear gear leg attach hole of the same left landing gear pointing forward to the alignment pin in front gear leg hole. This provides a view of an alignment that is off centerline by .250++". This would make it difficult to install the rear gear leg attachment bolt.

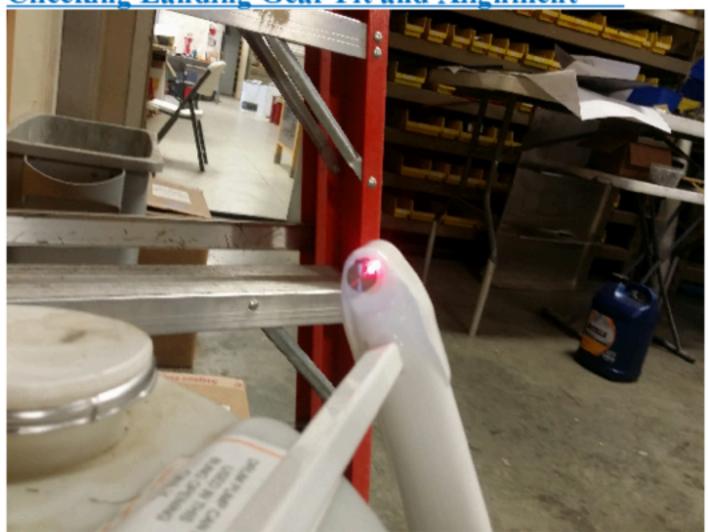
Laser attachment device placed in rear gear leg attach hole of right landing gear pointing forward to the alignment pin in front gear leg hole. This provides a view of an alignment that is off centerline by .312+". This would make it difficult to install the gear leg attachment bolt.

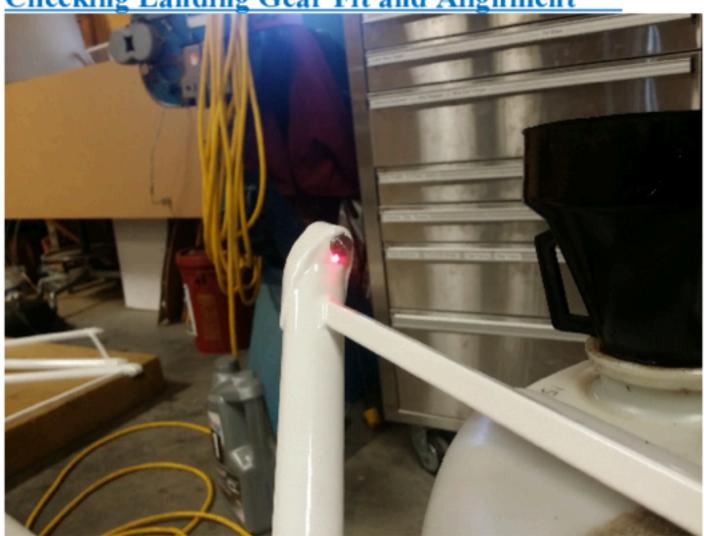
Laser attachment device placed in the front gear leg attach hole of the same right landing gear pointing forward to the alignment pin in rear gear leg hole. This provides a view of an alignment that is off centerline by .375+". This would make it difficult to install the gear leg attachment bolt.

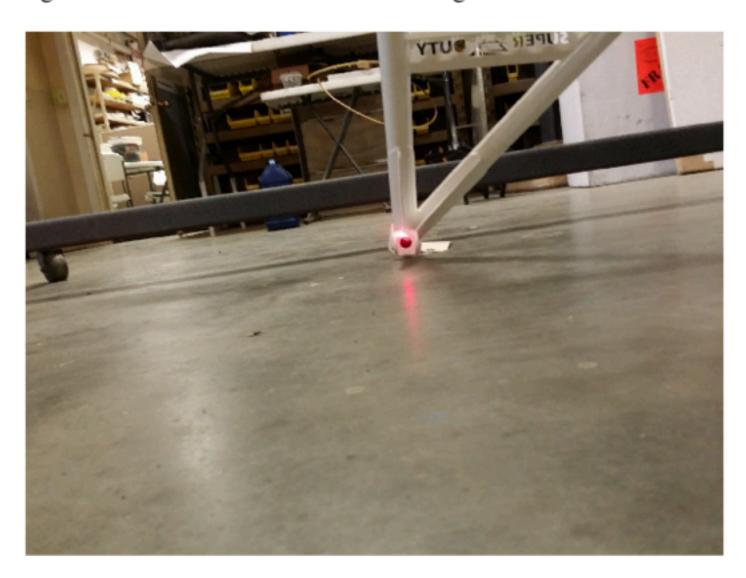
Laser attachment device reconfigured and attached to the bore of the left landing gear axle pointing towards the right landing gear axle. Only the fore and aft directions can be inspected as the vertical changes would come from the pivot motion of the landing gears at their attachment points on the fuselage. In this instance there is only a slight misalignment and could be considered "good".

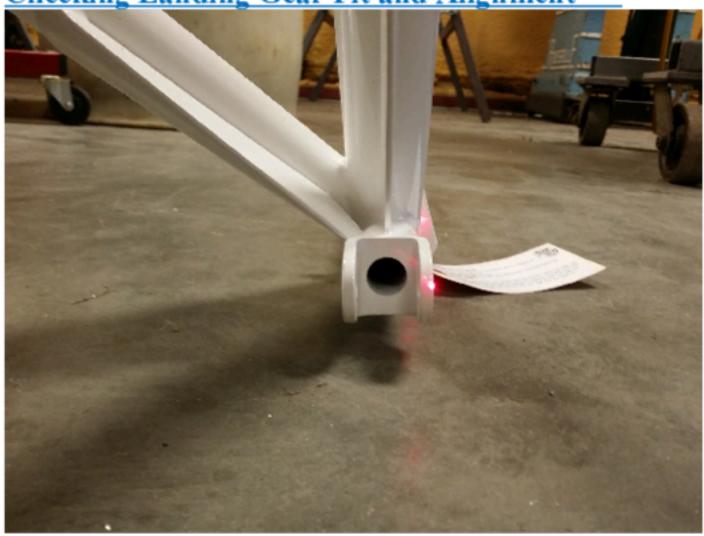
Laser attachment device reconfigured and attached to the bore of the right landing gear axle pointing towards the left landing gear axle. Only the fore and aft directions can be inspected as the vertical changes would come from the pivot motion of the landing gears at their attachment points on the fuselage. In this instance there is a misalignment of .750+" and corrective action might be considered.
