## **Model B - Maintenance Guide and Critical Inspection Points**

**Rev. A**

**Date: 24October 2010**

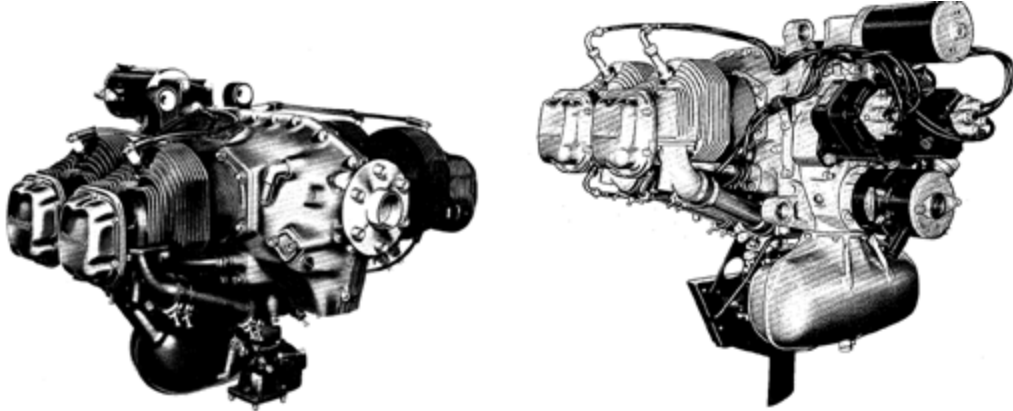
Note: Due to the number of engine's and options that have been installed on the Taylorcraft B model, this portion of the document will only attempt to highlight problematic areas of the most common engines. It needs to be reiterated that FAR 43 AND the manufacturers approved data must always be consulted when performing maintenance and Inspections.

- Engine section - for visual evidence of excessive oil, fuel, or hydraulic leaks, and sources of such leaks.
