Section 3: Engine Group

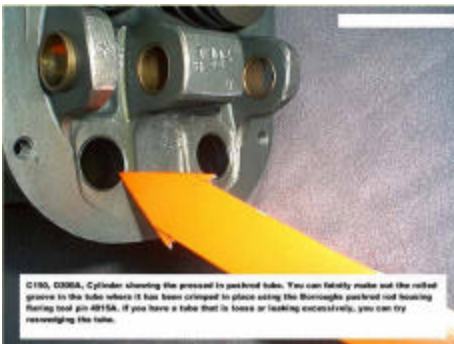
Very common to all the smaller Continental engines is push rod seal oil leaks. It is a rubber 'connector' that connects the push rod tube to the hydraulic lifter housing. The push rod tubes also tend to leak where they attach to the cylinder head. The tube is beaded and pressed into the head. The steel bead can fret into the aluminum head and loosen over time. Generally, these types of oil leaks do not compromise airworthiness and tend to be a nuisance more than anything. However, this is up to the mechanic and sometimes it is elected to repair or re-bead the push rod tubes and replace the seals. One thing to note on this is Teledyne Continental AD 94-05-05 R1 which requires the cylinder rocker arm boss to be dye penetrant inspected at each cylinder removal. New style push rod tube seals are available from a company called REAL as kits which add a spring and seal to the push rod tube and cylinder head. Typically this modification is done when the cylinder needs service and/or replacement but has also been successfully done in the field without removing the cylinders.

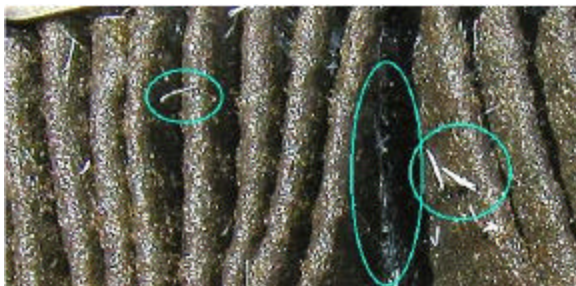
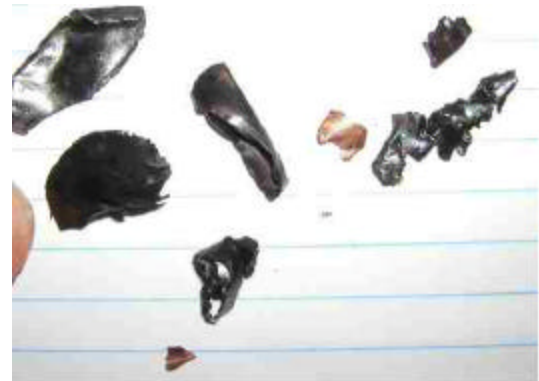
✿ It cannot be stated enough, the importance of the oil screen contents. This is by far the most important indicator of internal engine condition. The composition of the contents can be studied and the source can be pin pointed to almost the exact component by people trained in engine overhaul and heavy maintenance. As a rule of thumb; magnetic or ferrous materials are generally from the rotating group ie: gears, crankshaft and camshaft. Bronze is generally from plain bearings in the connecting rods and rocker arms. It can also be produced from the wearing in of valve guides. Non-ferrous or aluminum material is generally from the pistons, piston pins or crankcase (sometimes a spun bearing). Chrome particles can be from a number of sources including thrust or centrifugal bearings, piston rings, cylinder bore as well as other hardened surfaces. Black carbon is a sign of high temperature scorching the oil as is the case with blow-by or worse; a hole in the piston. Although engine component breakdown preceding a catastrophic failure can sometimes be caught during an inspection of oil and filter, the overall idea is to establish a trend of the engine wear and what is normal for that particular engine. You must take into considerations such as time since overhaul or major engine component replacement. It's not uncommon to see brass and chrome specks soon after a cylinder replacement as the rocker shaft bushings and cylinder bore and rings are breaking in. Below are some pictures of advanced wear in the screen of a spin on type oil filter. Anything beyond a speck or small sliver is reason to investigate further.

Spectro-analysis of the oil and filter can also be accomplished if something major is suspected. They will give you a complete graph of what was found and potential area's it came from. Another excellent resource is your local Aircraft Engine overhaul shop. Taking the oil filter contents into the shop and having a trained technician look at them is an excellent idea. Often times they will recognize the material immediately. They also can be a relief of anxiety when their evaluation is of completely normal wear.
